CASE Study - SPAIN

REMOVE THE DAMS FREE OUR RIVERS

Inturia dam removal in Oria River Basin

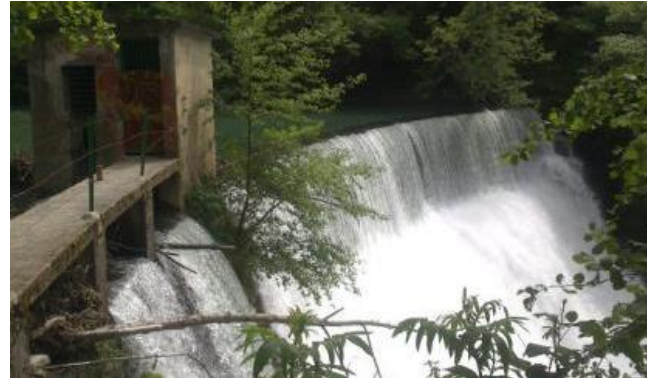
Inturia dam before removal © Basque Water Agency)

The largest dismantled dam was the Inturia dam with 12,5m height. The Inturia dam was located at the Leitzaran River which is part of the Natura 2000 area and catalogued as a protected biotope.

The Inturia dam was constructed in 1913 for hydropower generation and flow regulation in summer. During the dam life span sediments were piling up behind the wall. In the years 1990 the dam was out of use and considered as an industrial ruin. The structure needed to be completely renovated or dismantled. Technical and economical analysis came to the conclusion that demolition was the most economic and best ecological option.

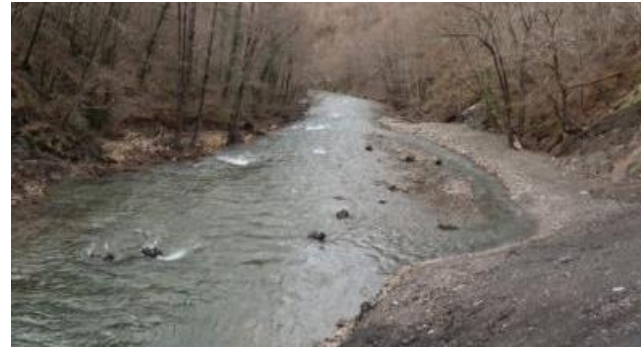
Leitzaran river after dam removal © Basque Water Agency

The demolition works were carried out by the Basque Water Agency. So far fish community has recovered and new spawning area was created. [Watch the removal video](#)

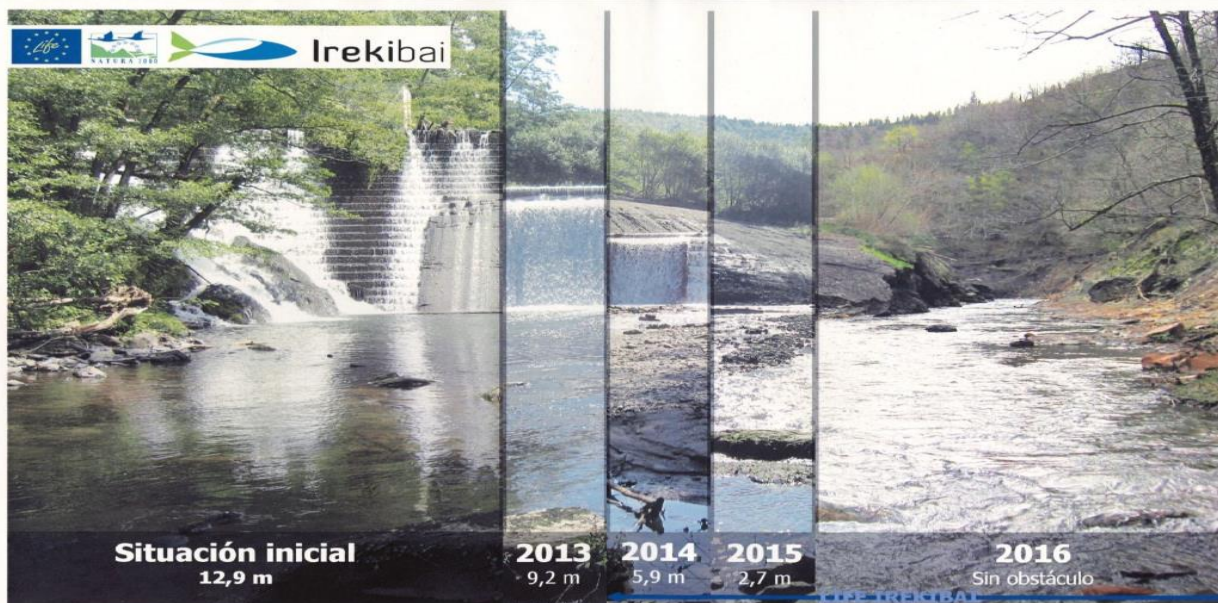
4 Phases of
dam removal

In 2009 the Gipuzkoa Provincial Council drafted the demolition project which was successfully implemented in 4 stages during 2013-2016.

The first and second phase were done from 2013 - 2014 and financed via the GURATRANS (EFA221/11), transboundary project of Spain-France-Andorra Cooperation and co-funded by FEDER, with the collaboration of Navarra, Atlantic Pyrenees and Basque Country entities.

The third and fourth phase were implemented between 2015 - 2016, and were part of the IREKIBAI LIFE project, a collaboration of Gipuzkoa Regional Government, Navarra Regional Government, the Basque Water Agency, GAN (Environmental Management of Navarra) and HAZI.
