CASE Study - SPAIN

Basque Water Agency

Inturia dam removal in the Oria River Basin

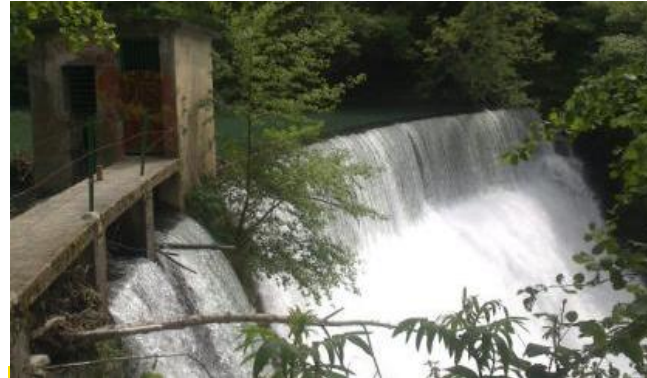
Inturia dam before removal © Basque Water Agency

The Inturia dam was constructed in 1913 for hydropower generation and flow regulation in summer. During the dam life span sediments were piling up behind the wall. In the years 1990 the dam was out of use and considered as an industrial ruin. The structure needed to be completely renovated or dismantled. Technical and economical analysis came to the conclusion that demolition was the most economic and best ecological option.

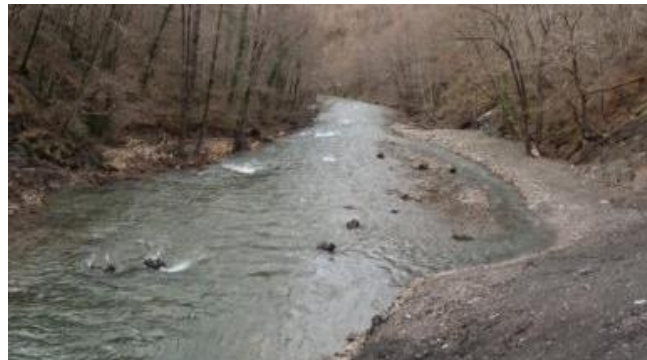
Leitzarain River after dam removal © Basque Water Agency

The demolition works were carried out by the Basque Water Agency. So far fish community has recovered and new spawning area was created.

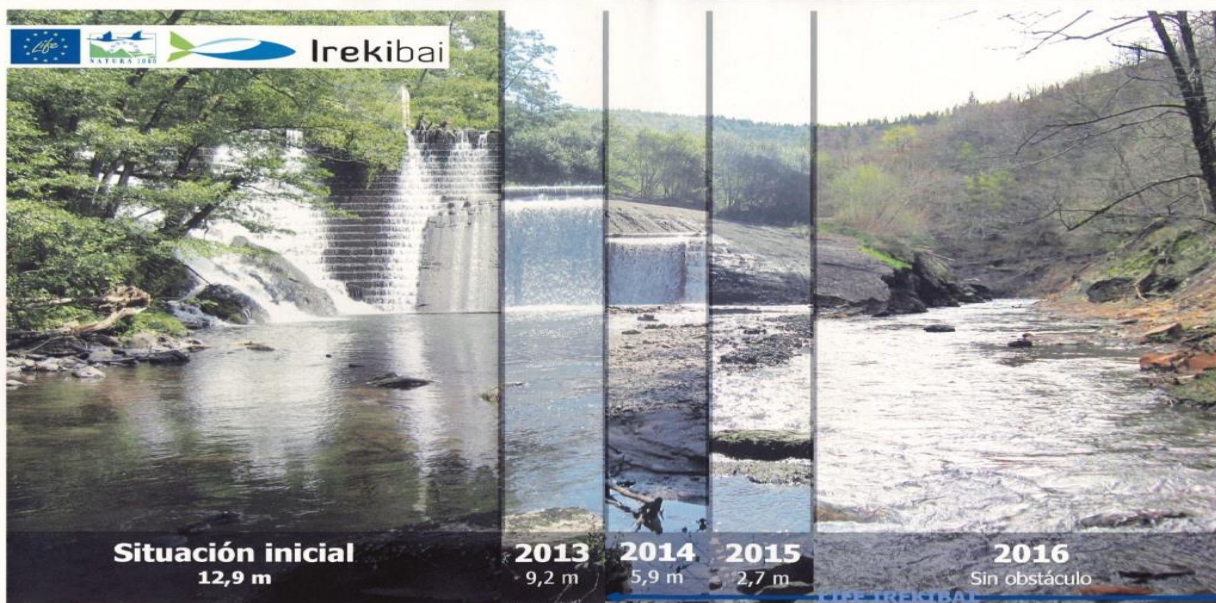
4 Phases of
dam removal

In 2009 the Gipuzkoa Provincial Council drafted the demolition project which was successfully implemented in 4 stages during 2013-2016.
