The Forest in the Vjosa River basin: an assessment of the situation

University of Natural Resources and Life Sciences Vienna

December 2022

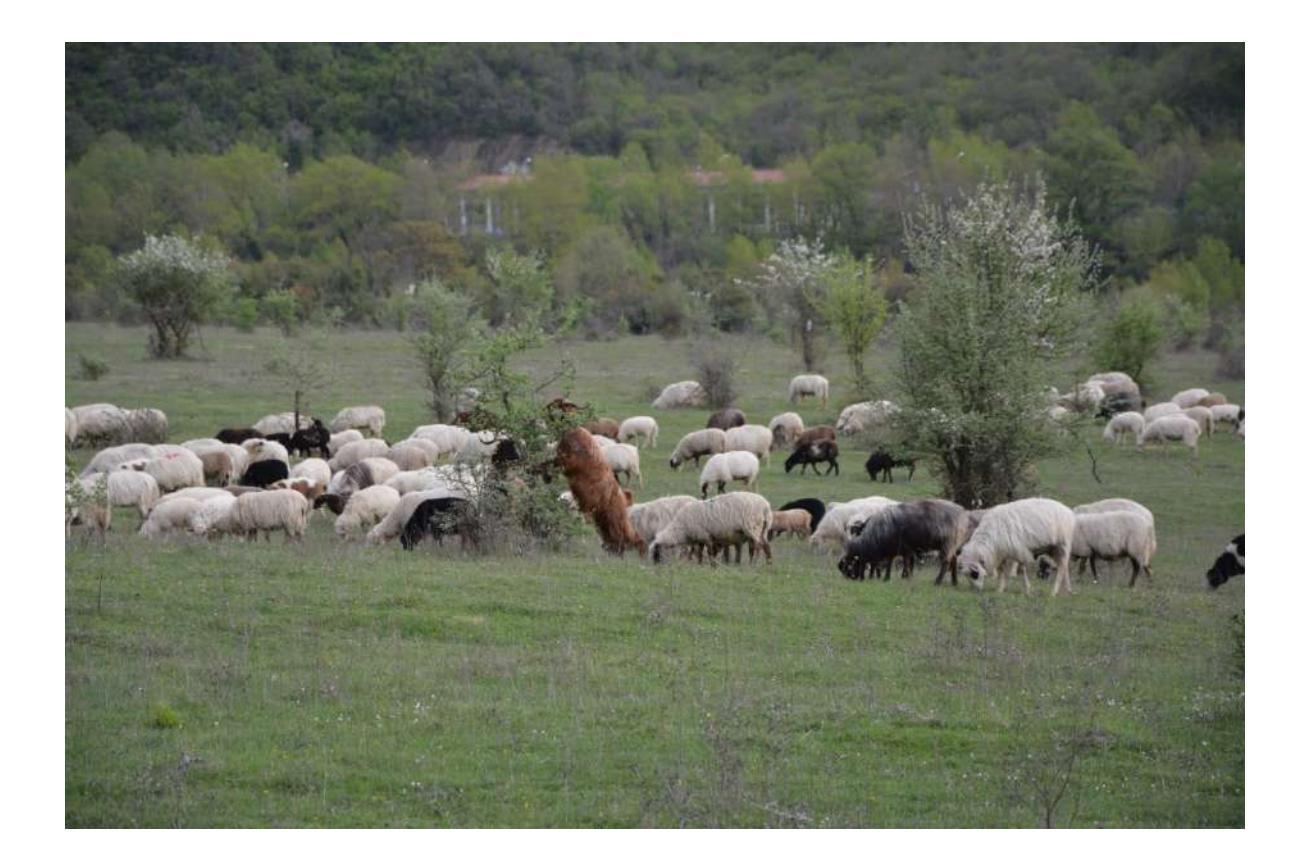
Figure 6: Livestock farming near the creek boarder. Large herds of sheep and goats impact the vegetation and especially natural regeneration.

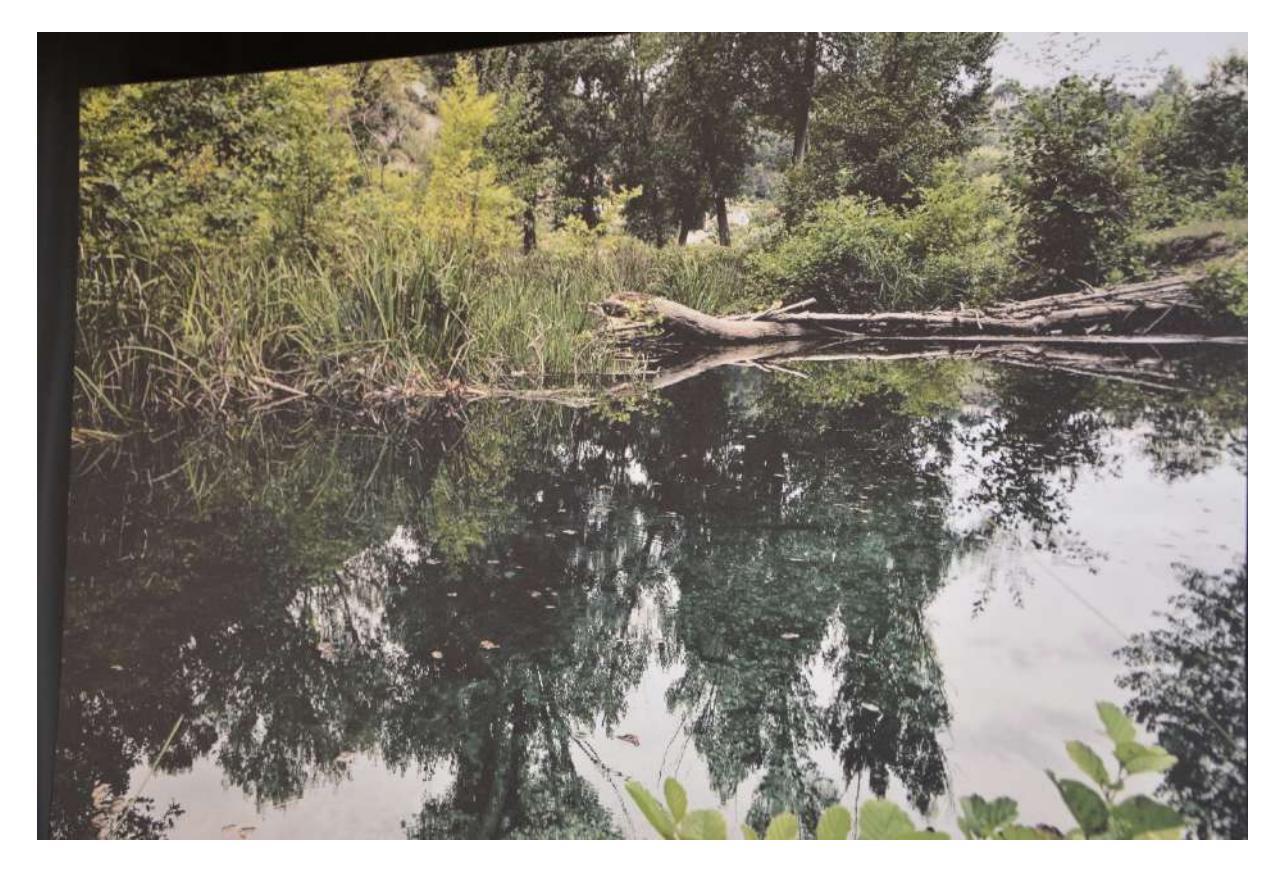
Figure 17: The Flood plain forest near Tepelena prior to the cutting.

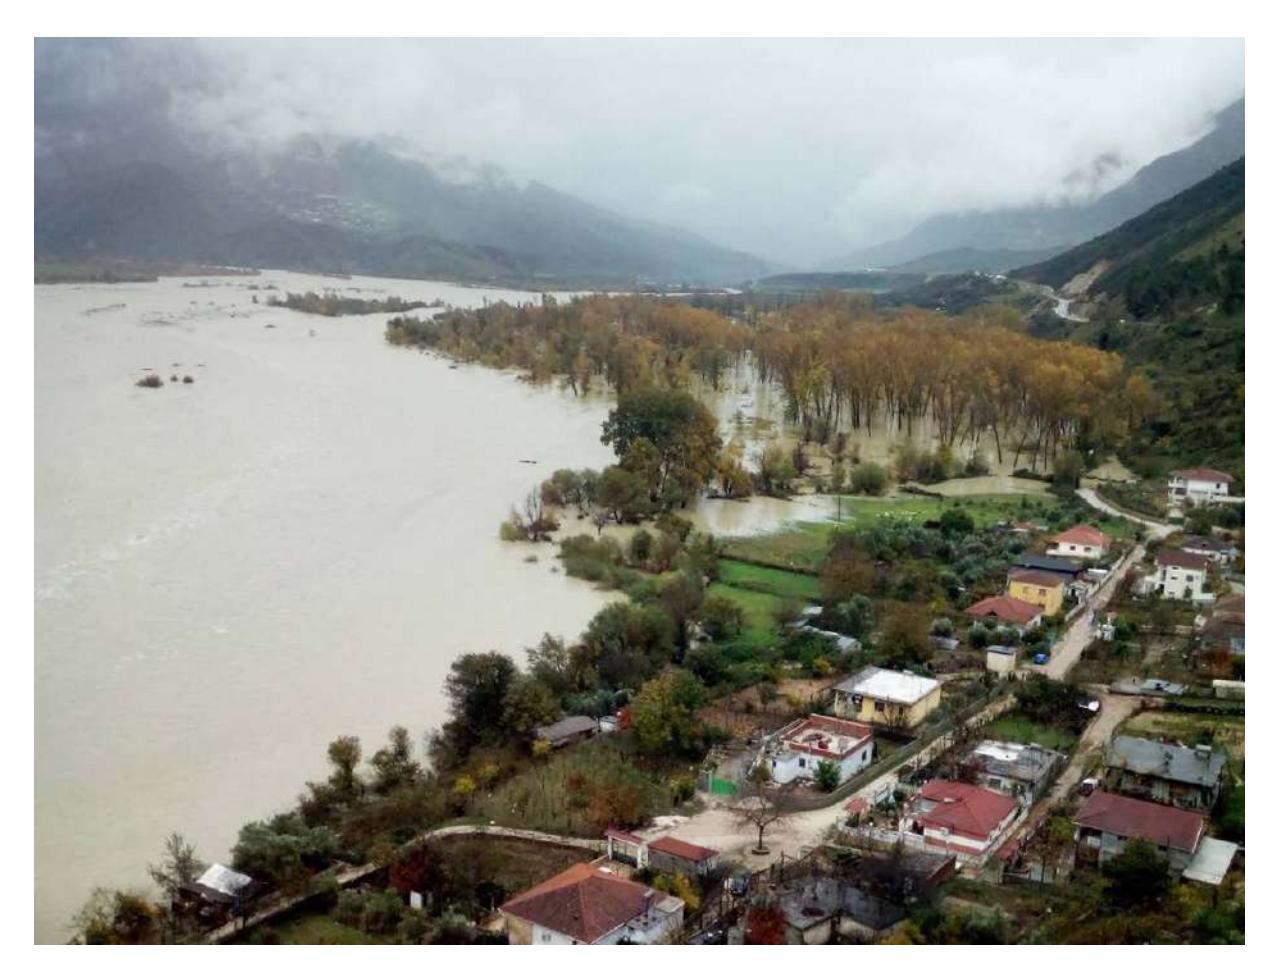
Figure 18. Typical flood of the Tepelena forest area during autumn/winter after heavy rain fall. The photo shows the situation prior to the clear cut of the forest area and demonstrates why a forest in this area is important to avoid erosion.

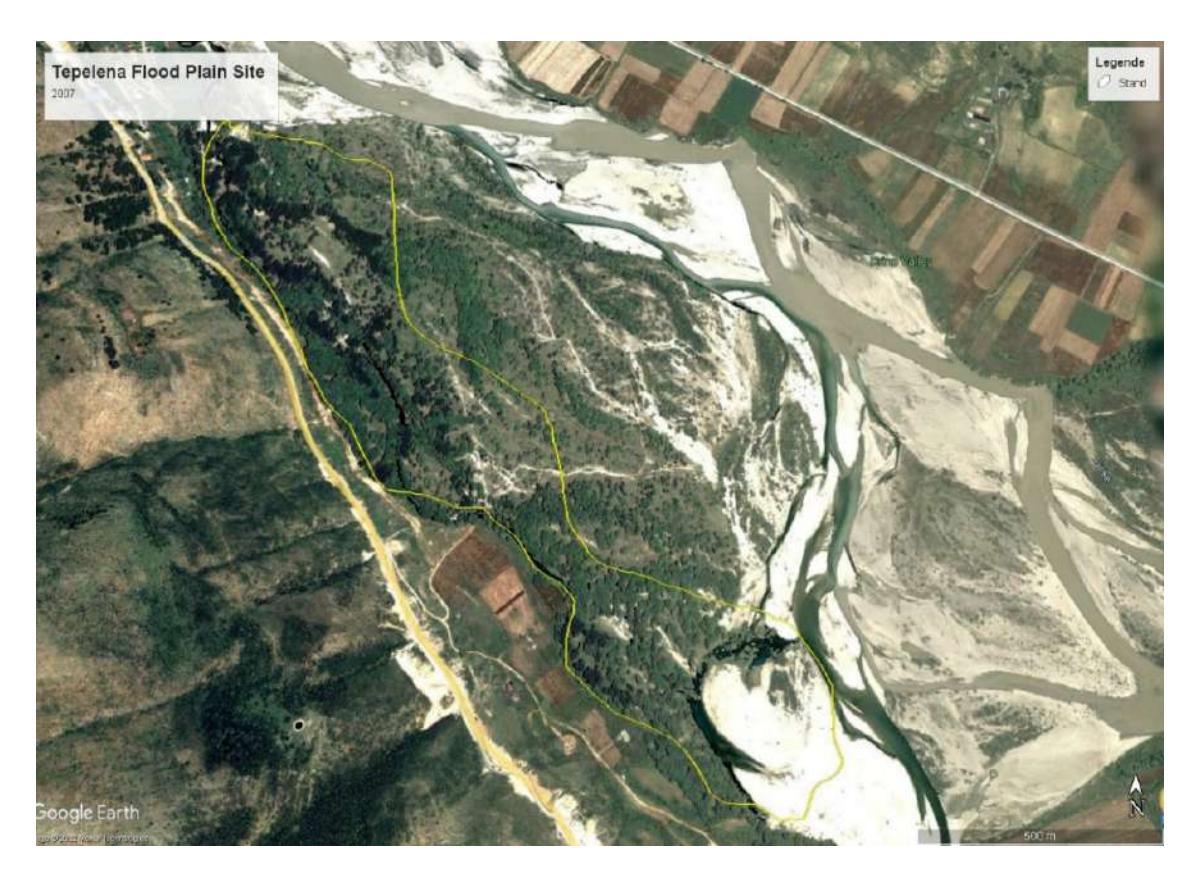
Figure 19. In 2007 the forest stand area was roughly 100 ha, about double the size of today (51 ha). The southern part of the area used to be a sand bank.

Between 2007 and 2022, the Tepelena flood plain forest (Figures 19 to227) went through a severe loss in area from nearly 100 ha to about 50 ha. Although it is common that rivers show a dynamic behavior, the uncontrolled clear cuttings have induced a dramatic expansion of the sedimentation process on former forest land since the speed of the water flow increased. If the replanting process of the remaining area fails, it is expected that the ongoing sedimentation process will even lead to further decline of the forest area.

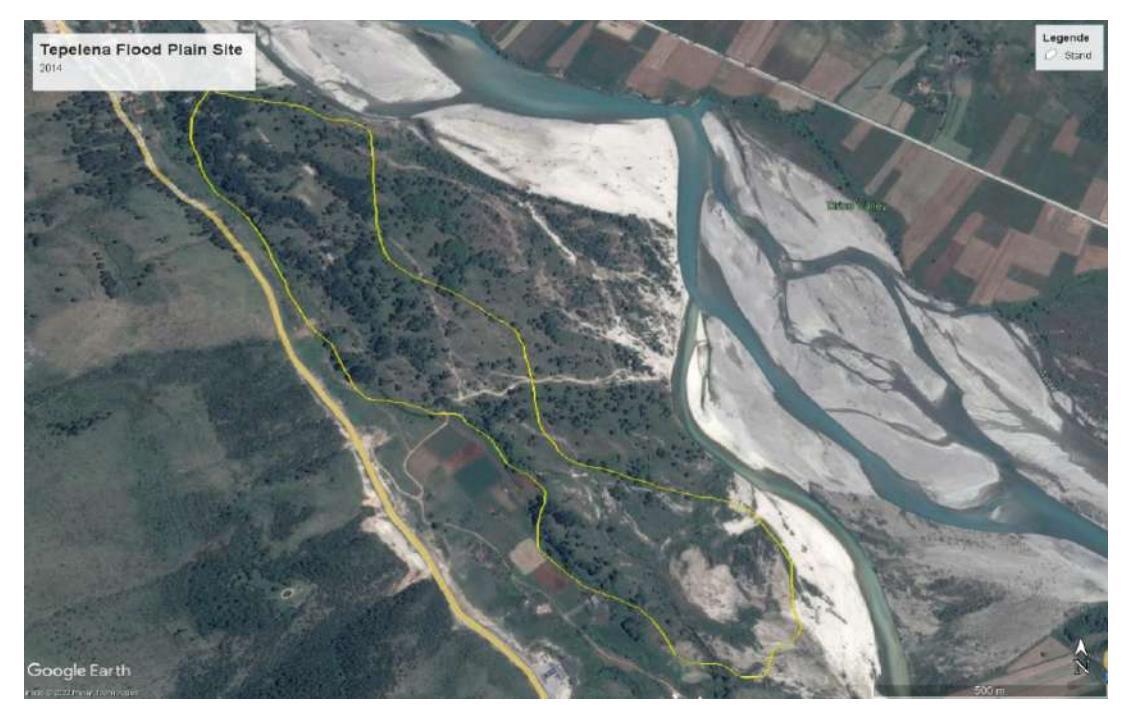
Figure 20. Between 2007 to 2014 the forest area expanded because trees regnerated also in the southern part of the area.

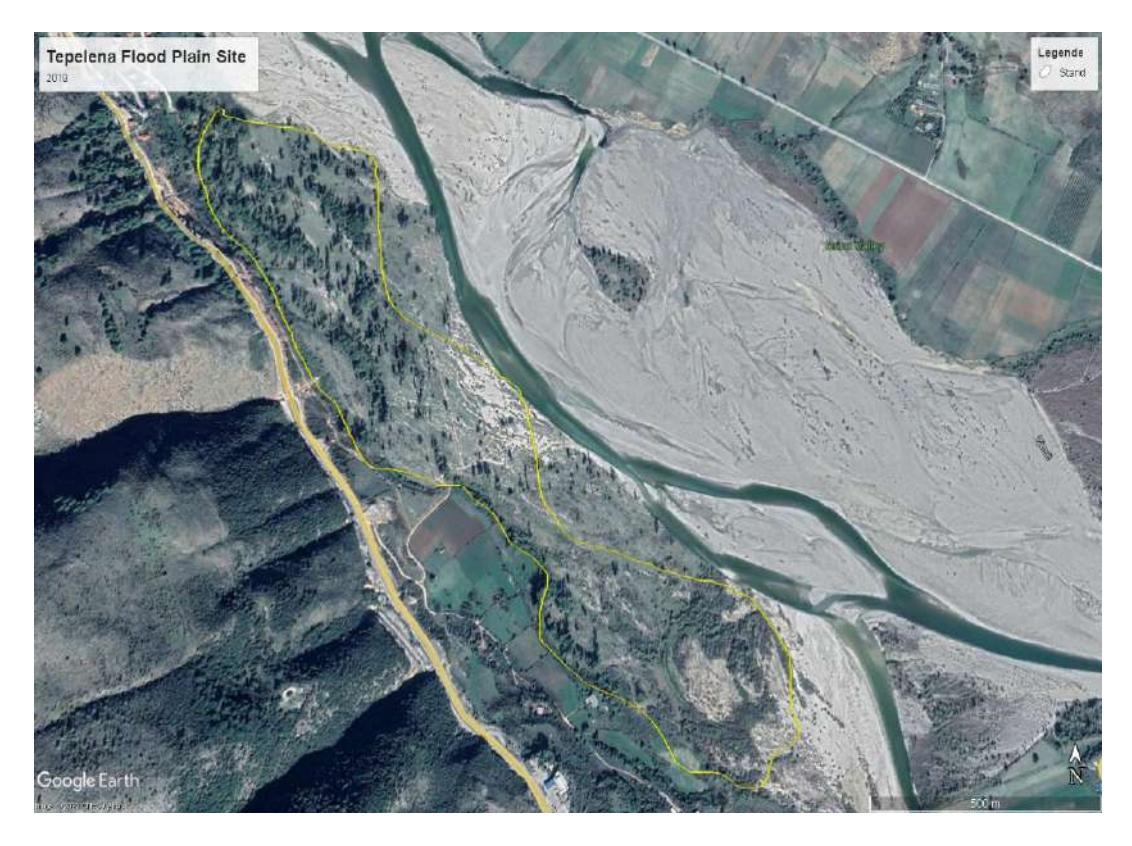
Figure 21. Between 2014 and 2019 clear cuts took place and large parts of the forest was harvested, resulting in a rapid extension of the river sand bank.

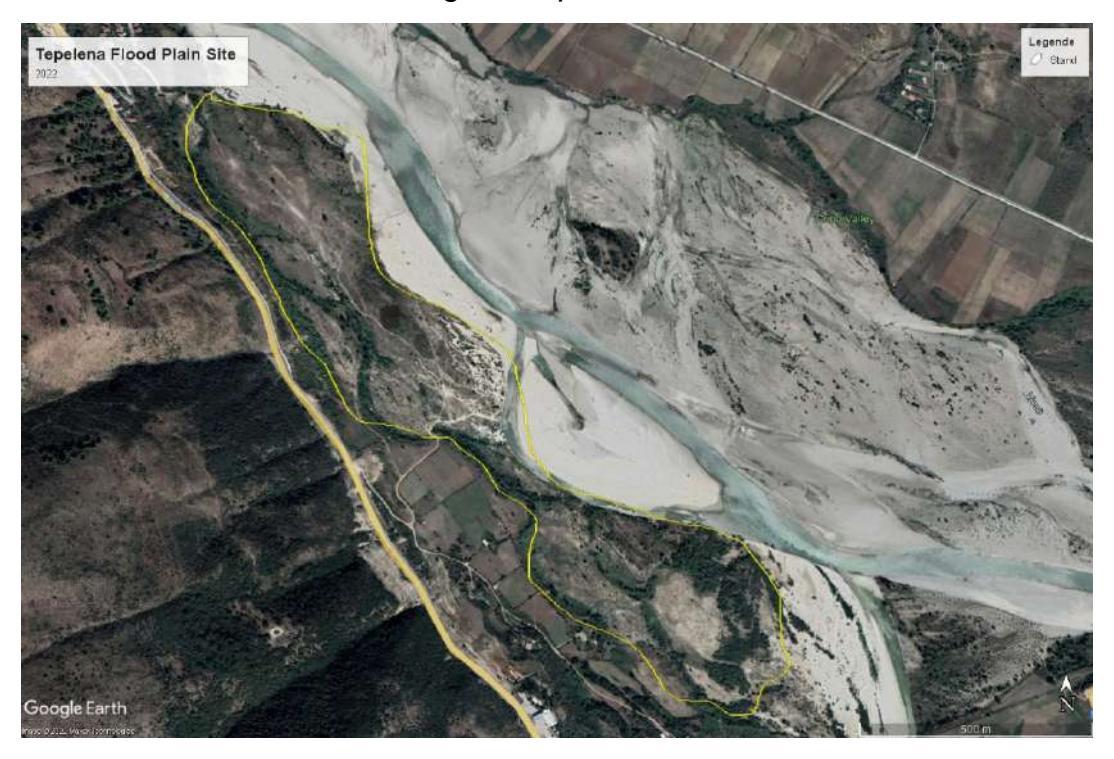
Figure 22. Between 2019 and 2022 the remaining Populus nigra trees covering the northern part were harvested resulting in a further loss of forest area. The yellow line shows the remaining current forest coverage after clear cut in 2022.

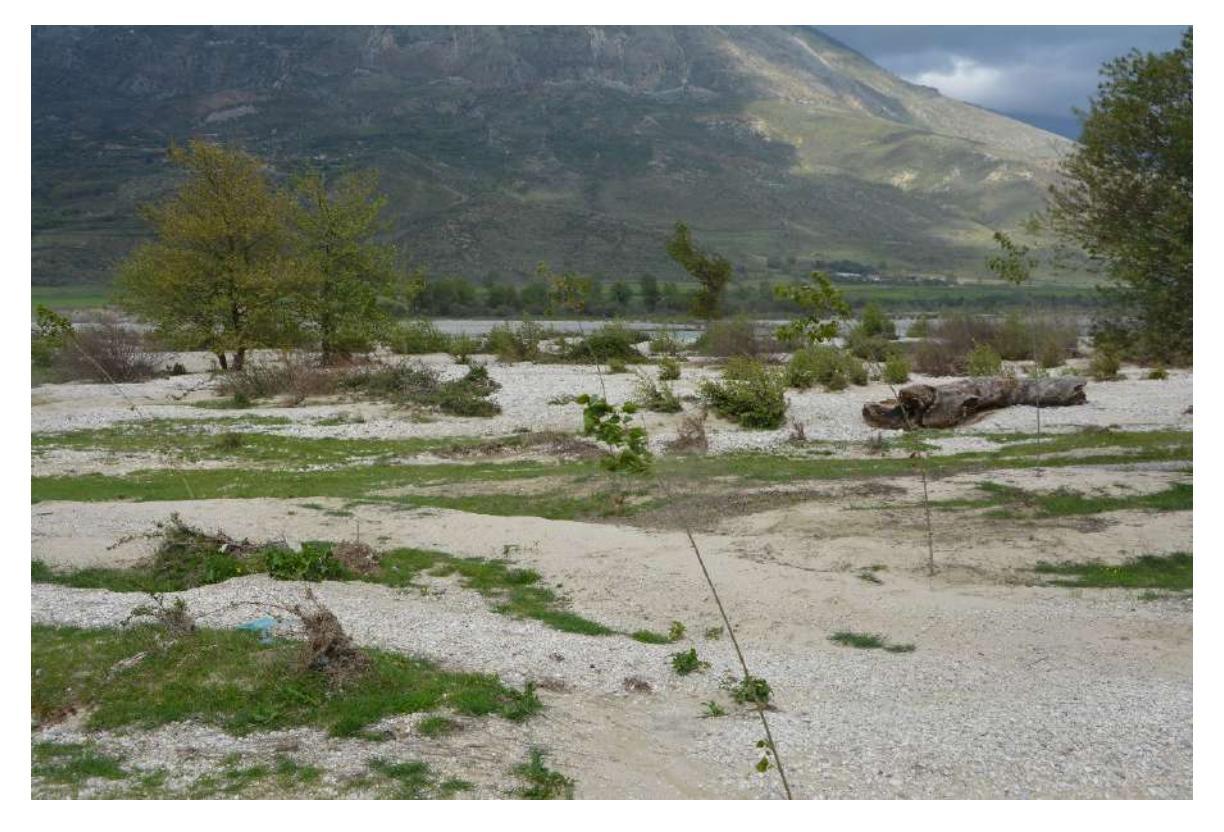
The floodplain forest of the site dominated by poplar trees with an age over 40 years old was clear cut because some dieback signs were noted affecting the trunk and the tree crown. These health problems were caused by Armillaria root rot which attack the root system of the poplar and weakened the tree vigor. The fungus can spread from one tree to another by rhizomorphs that grow through the soil until they contact and infect a root of another tree. Mycelium of the fungus then spreads through the root system of that tree, causing root rot and eventually butt rot.

Figure 23. Current stand situation. The flood plain forest consists of some remaining *P. nigra trees and planted Hybrid popular (P. xcanadensis).*

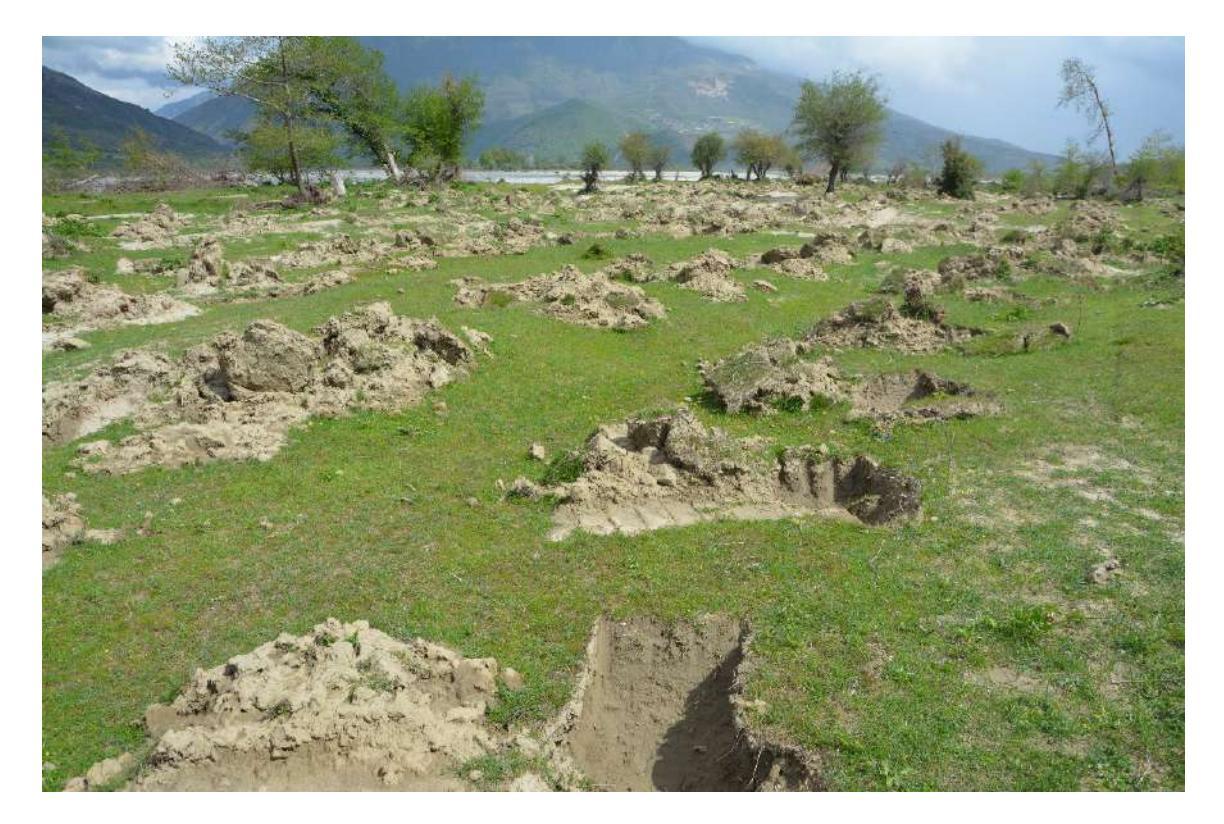
For replanting the area an excavator was used to create holes for planting the hybrid popular heister. This resulted in additional problems such as soil compaction of the sensitive flood plain humus and soil layer, and even more erosion problem (see Figures below). Furthermore, Hybrid popular is non-native to the area and thus from a nature conservation perspective this species should not be planted.

Figure 24. Site preparation efforts for planting.

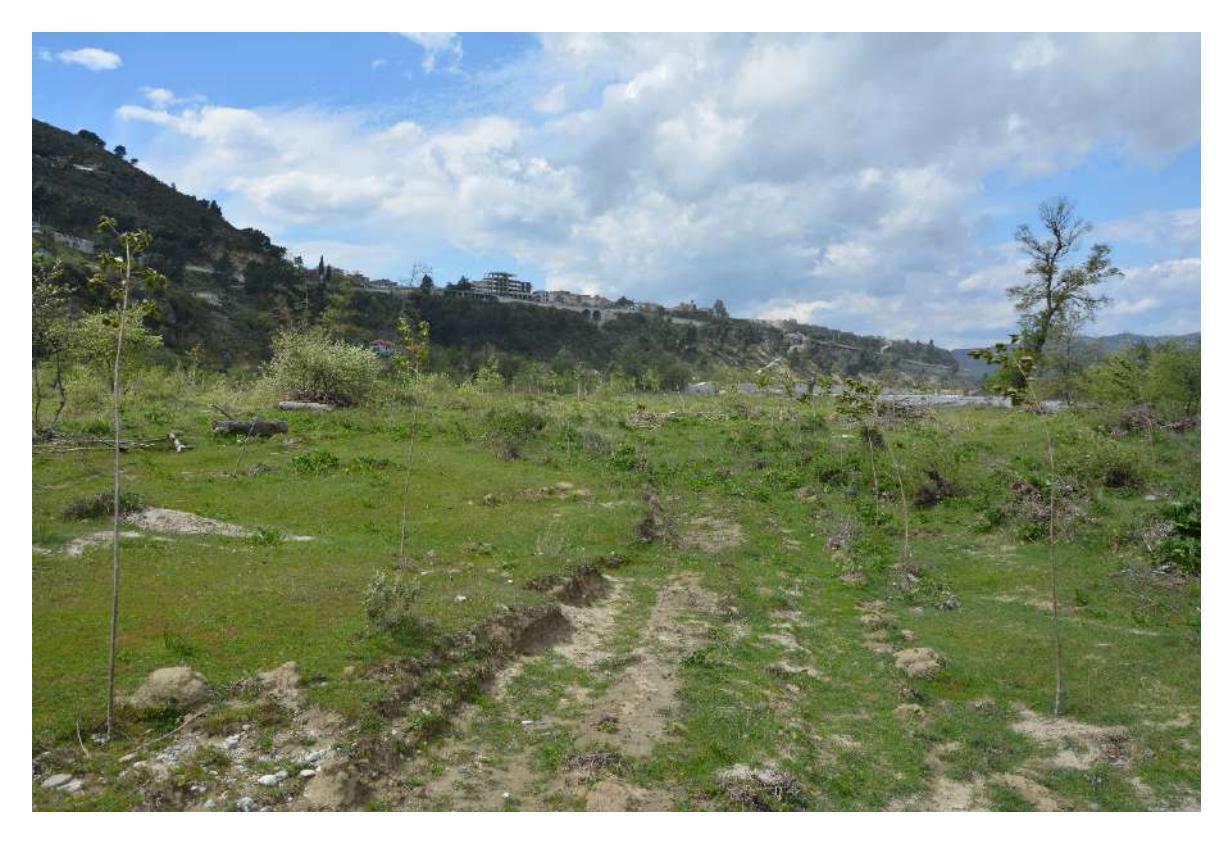
Figure 25. Soil compaction from heavy machinery.

- No heavy machinery for planting to avoid soil compaction and further erosion.
- Removal of the whole Paulonia trees in the area to avoid future seed contamination.
- No Hybrid popular plantations
- Live-stock farming in the area needs to be controlled to avoid further damage to the sensitive humus and soil layer as well as to induce natural regeneration which is currently destroyed or damaged by browsing.
- Planting of native tree species (Salix, Platanus, Popular, etc.) coming from regional seed sources.
- Rigorous restriction of livestock grazing and/or browsing protection in the whole flood plain area.

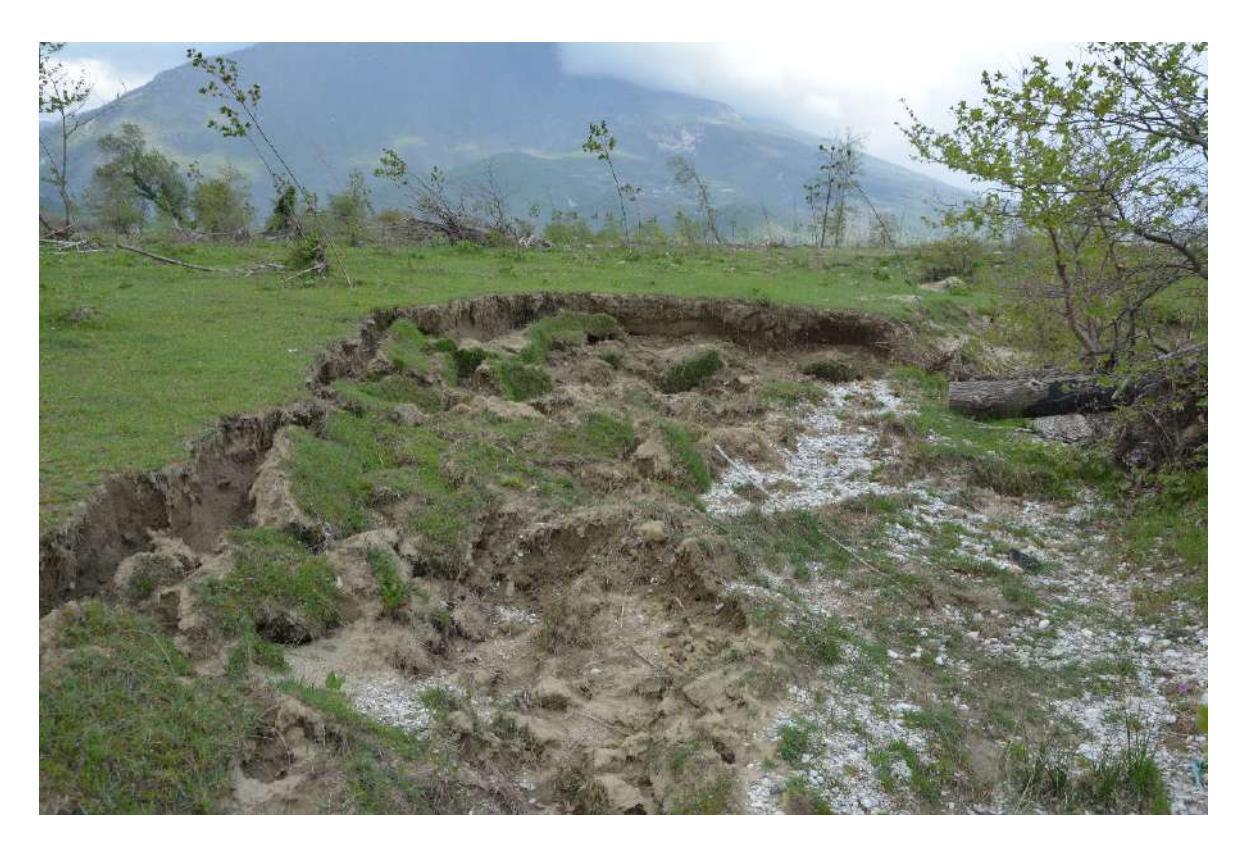
Figure 26. Example for an eroding patch. Fertile humus is gone and gravel and/or sedimentation remains. A replanting of eroded areas is difficult, very expansive or even impossible.

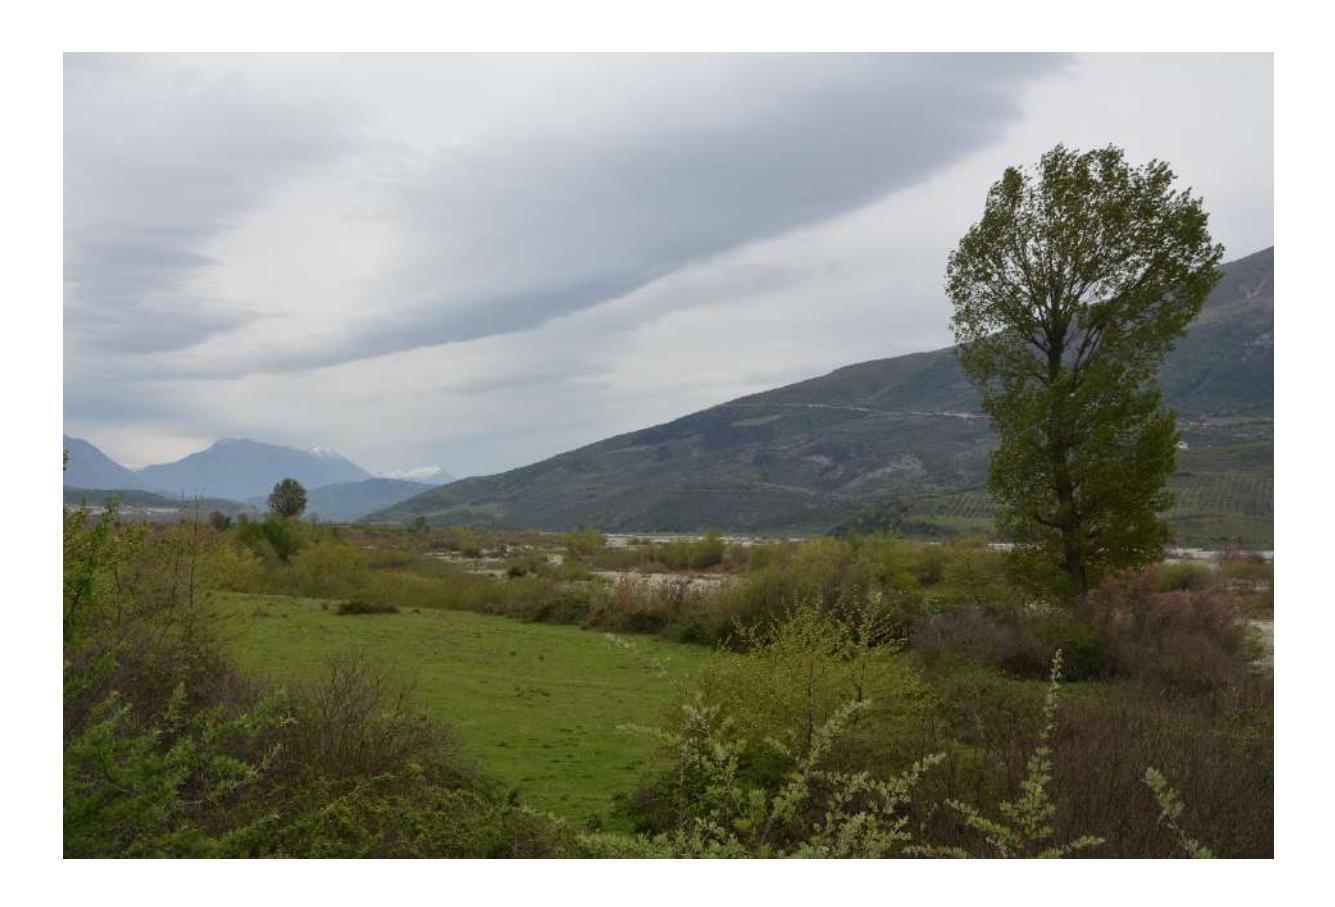
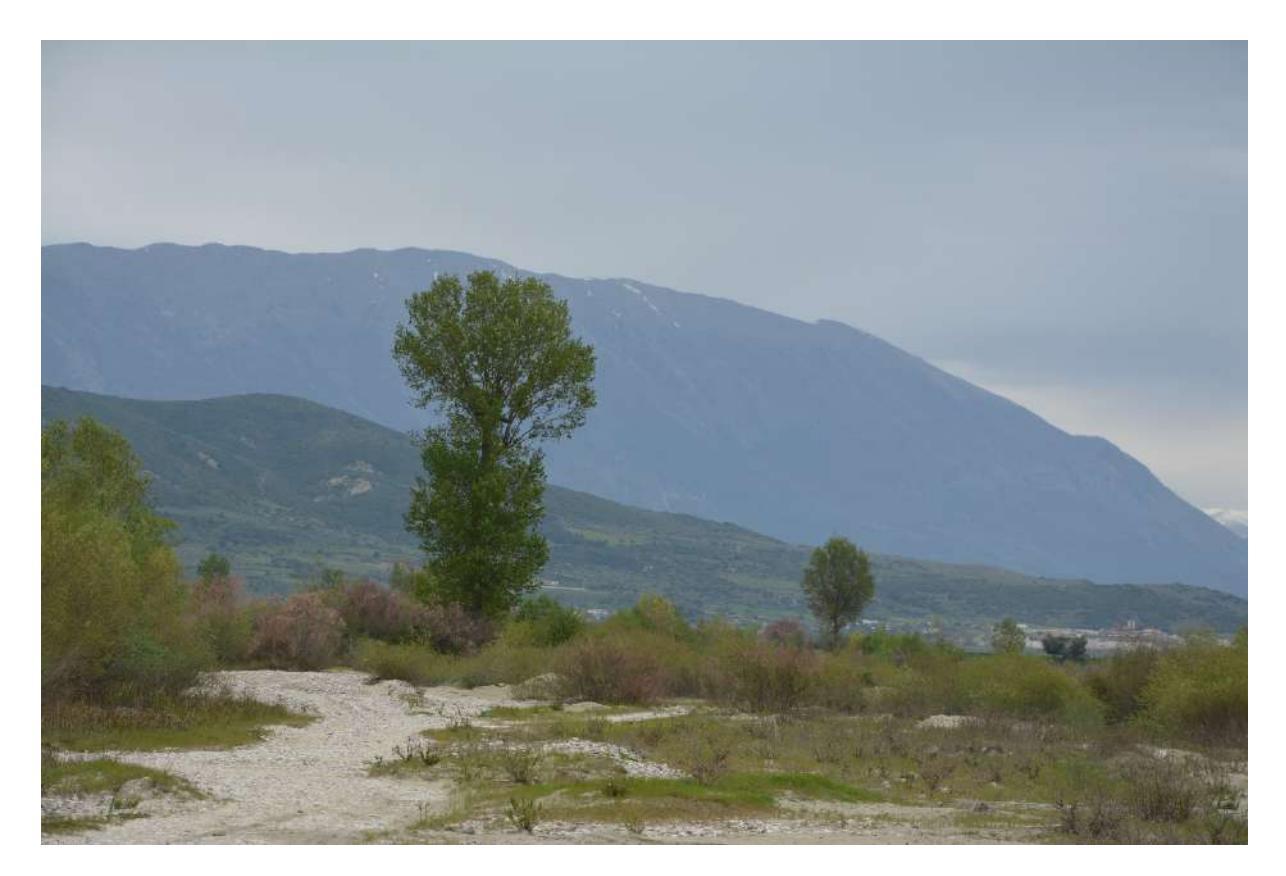
Figure 30. Stand situation after the large cuttings with the remaining individuals.

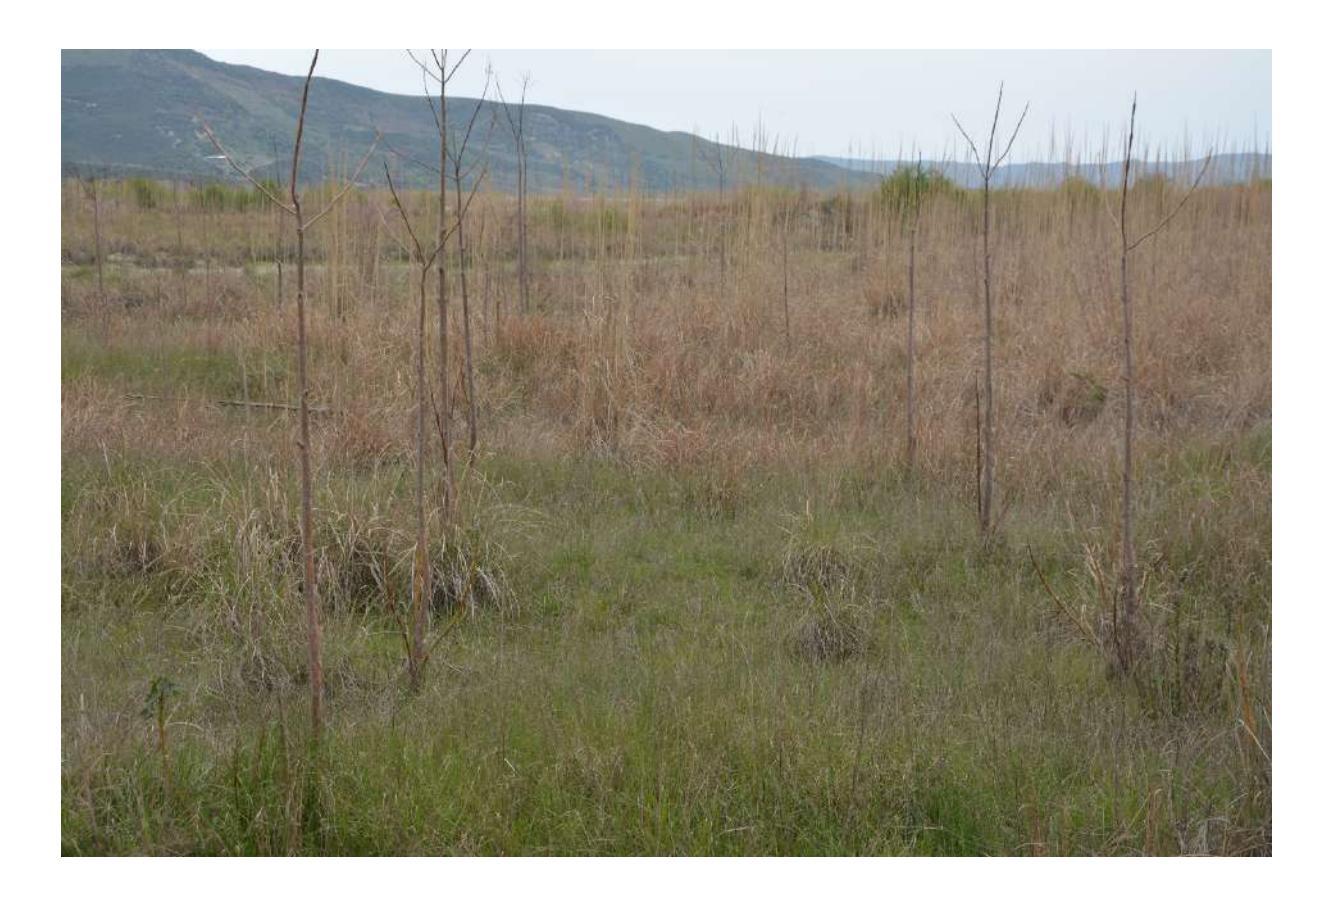
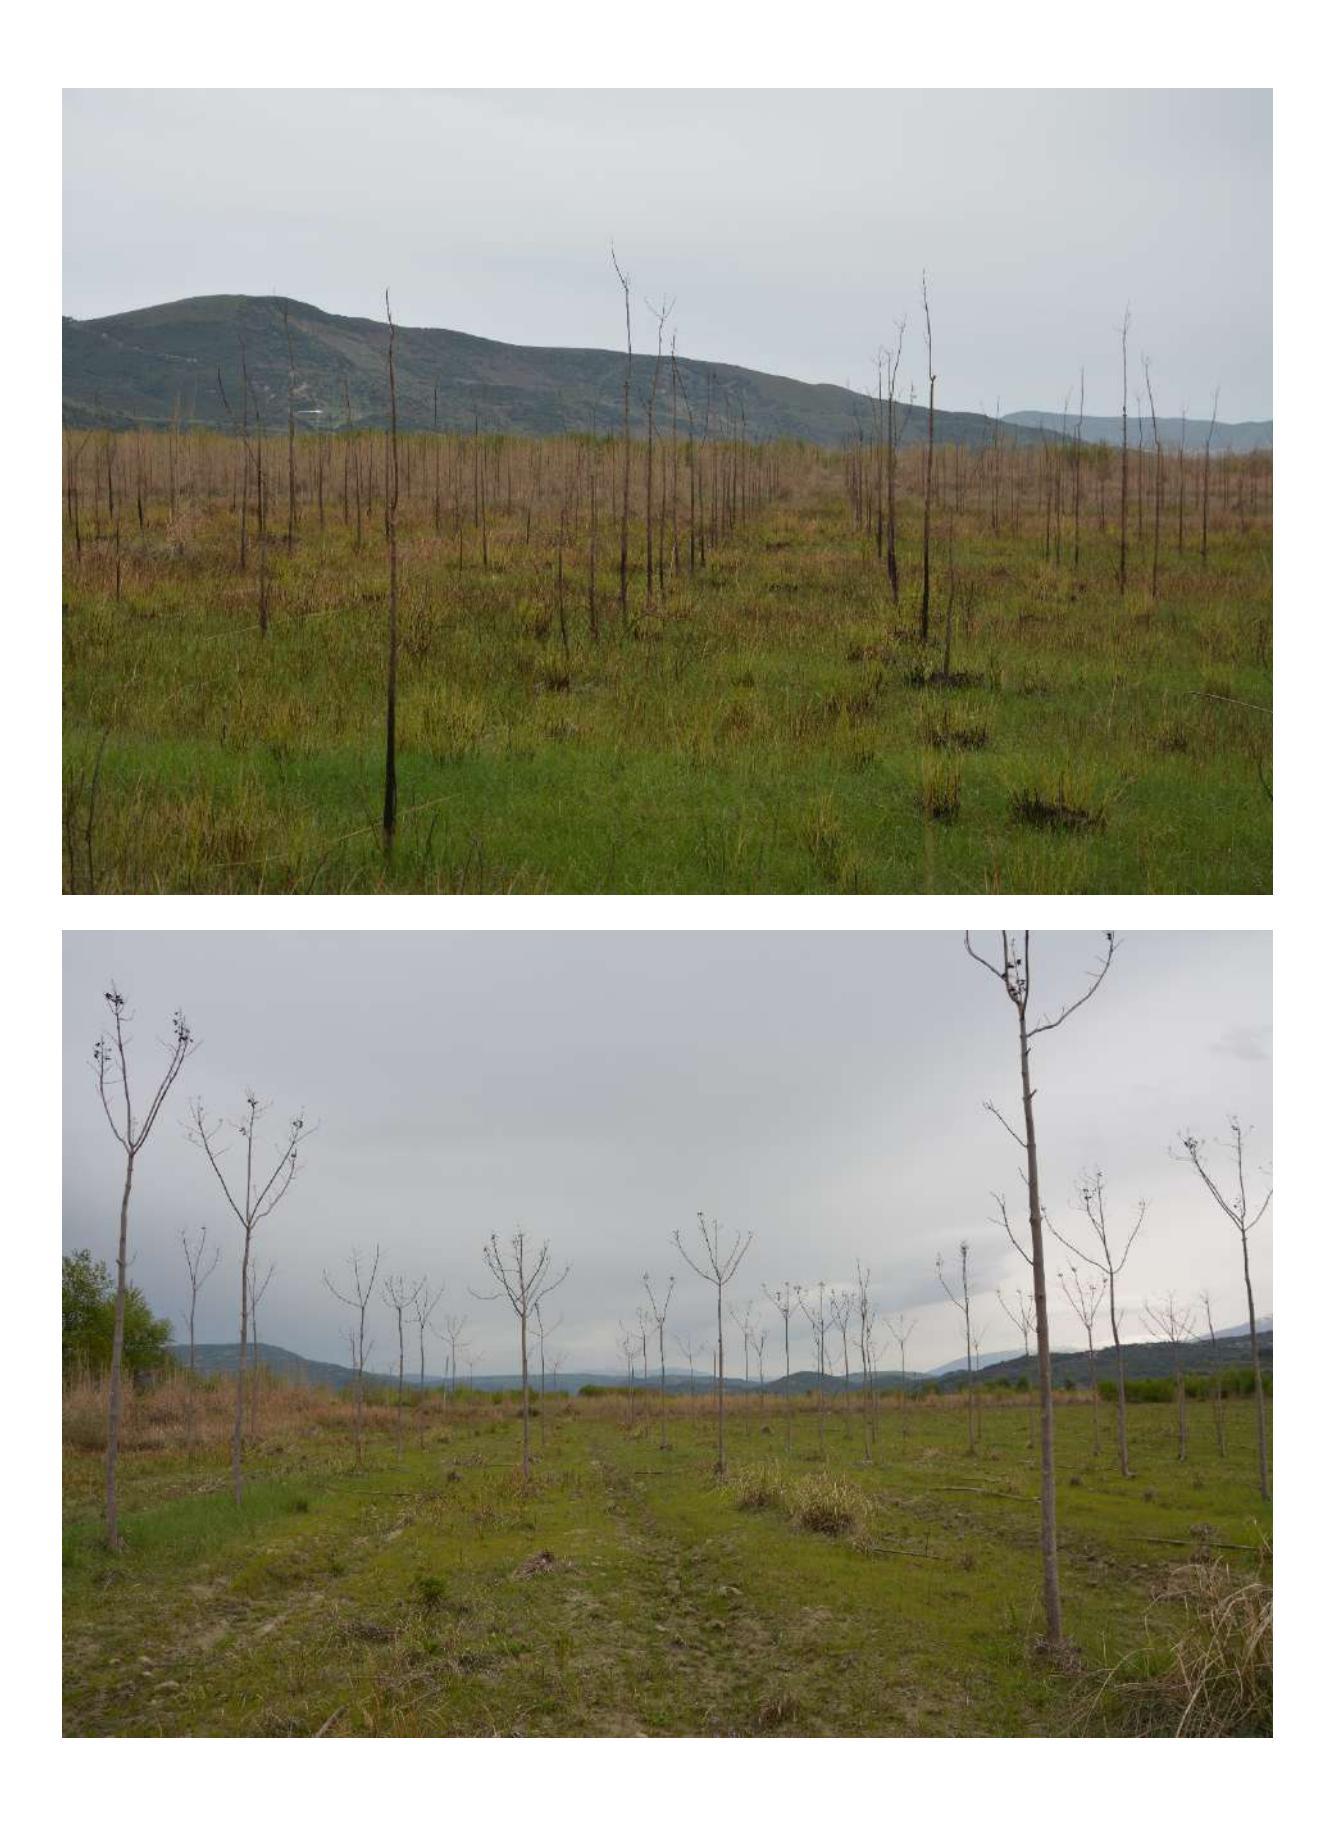
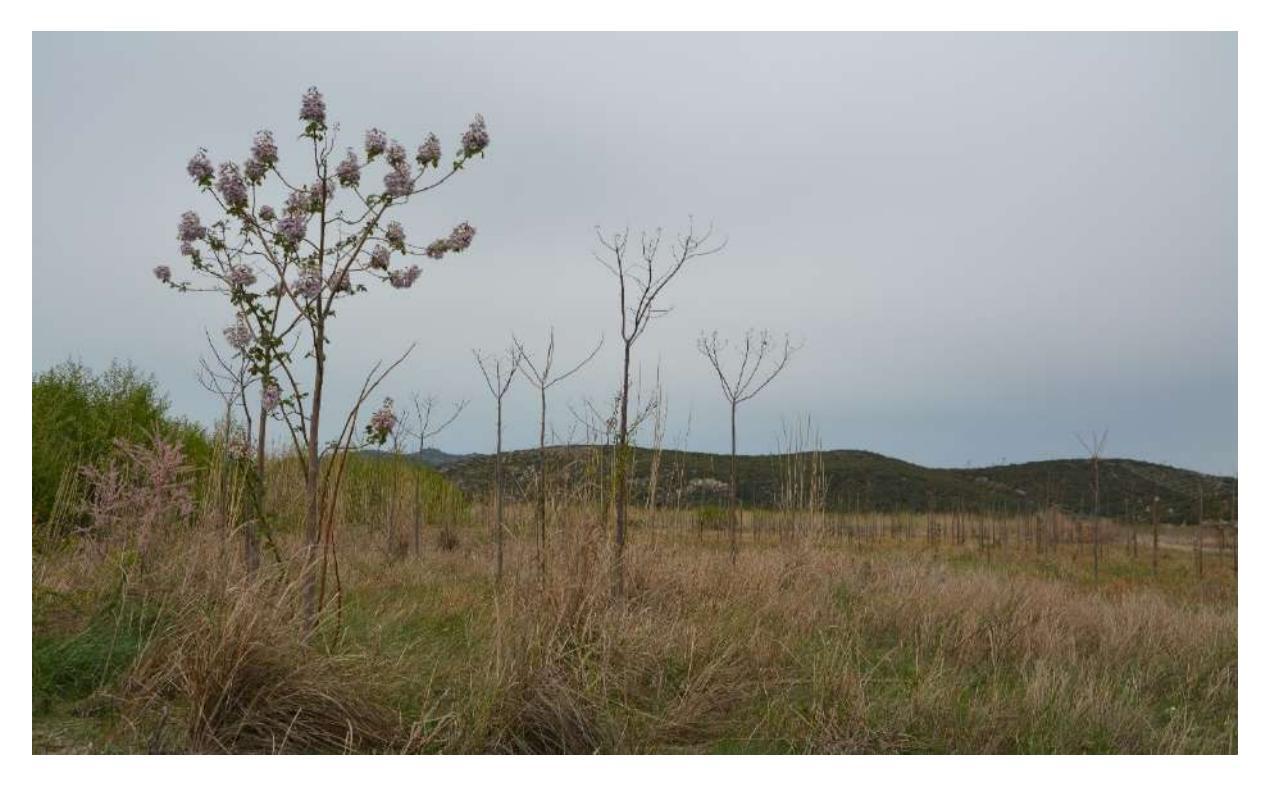
Thus, it is no surprise that most of the Paulonia plantations died after planting. The only exception is a Paulonia stand planted near the edge of the flood plain and the nearby hills – this site exhibits a lower ground water level and has a higher sand content (see Figure 32)

Figure 31. Series of photos of the Paulonia plantation which died due to the unsuitable site conditions for the species. Note the species needs semi-dry and semi-nutrient rich and warm soils. Thus, flood plain sites are unsuitable for Paulonia plantations.

The Paulonia plantations should be replaced by a flood plain forest planation of the following species composition (see also Tepelena site):

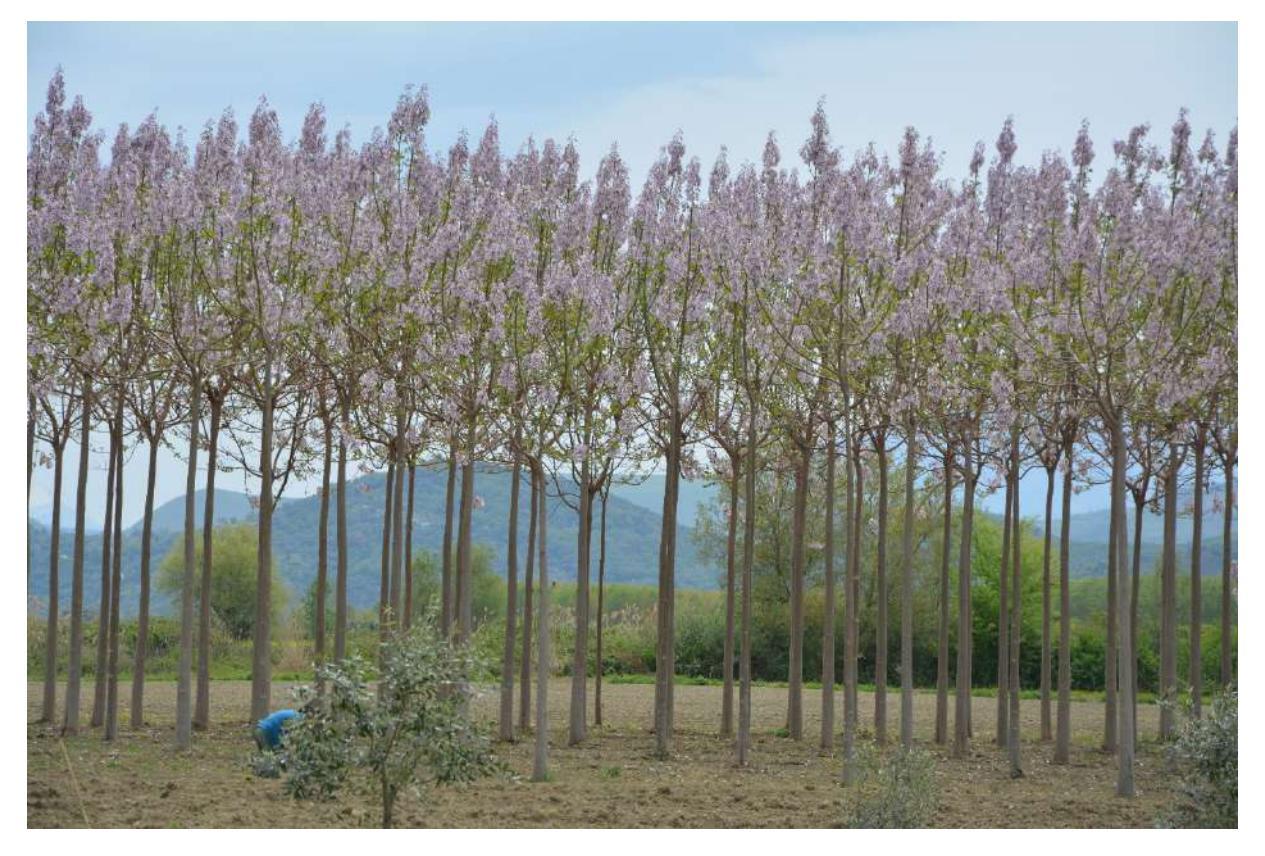
Figure 32. The only Paulonia stand that survived since it was located higher up on dryer site with warmer soil conditions.
Future Management Recommendations

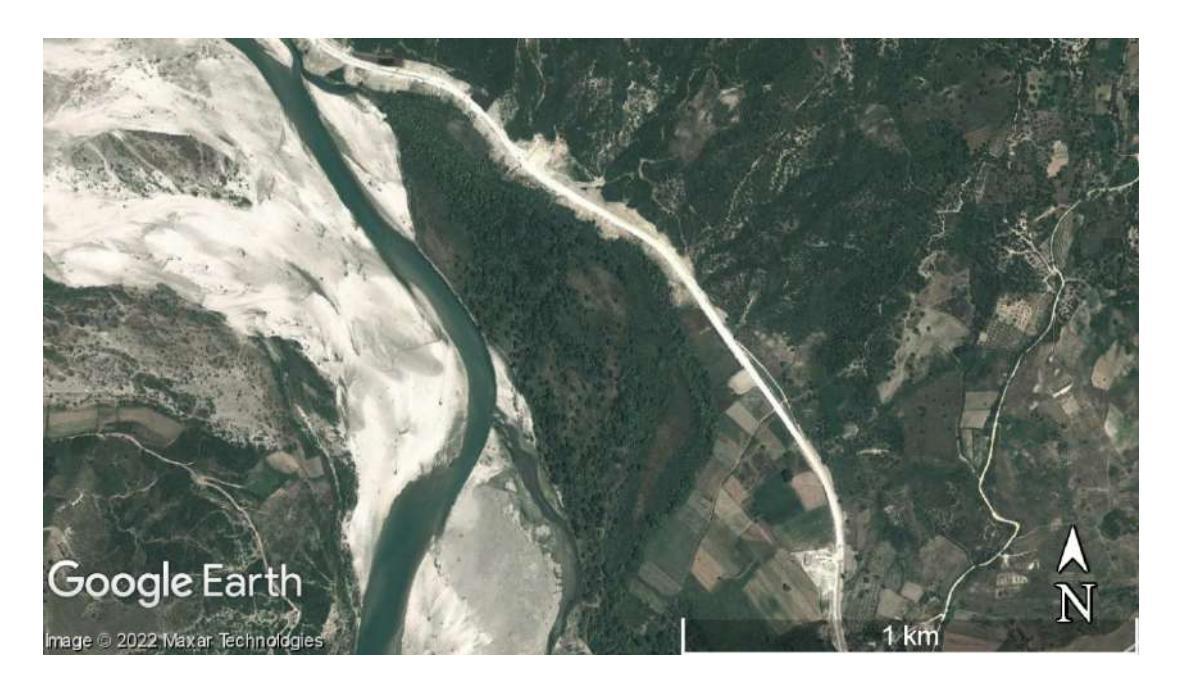
Figure 34. In 2011 the floodplain forest area was roughly 35 ha, compared to todays 28 ha.

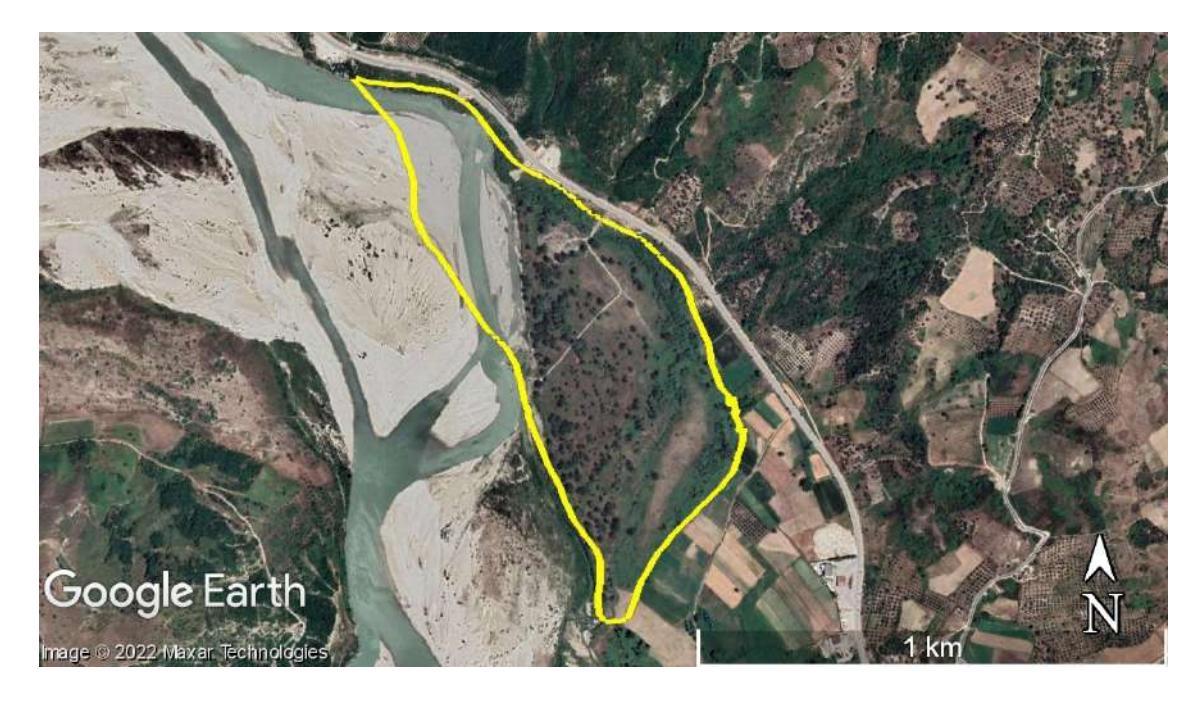
Figure 35. Between 2011 and 2016 a 7 ha in the norther parts of the stands erroded into the river. The yellow lines marks the stand border from 2011.
