The Forest in the Vjosa River basin: an assessment of the situation

University of Natural Resources and Life Sciences Vienna

December 2022

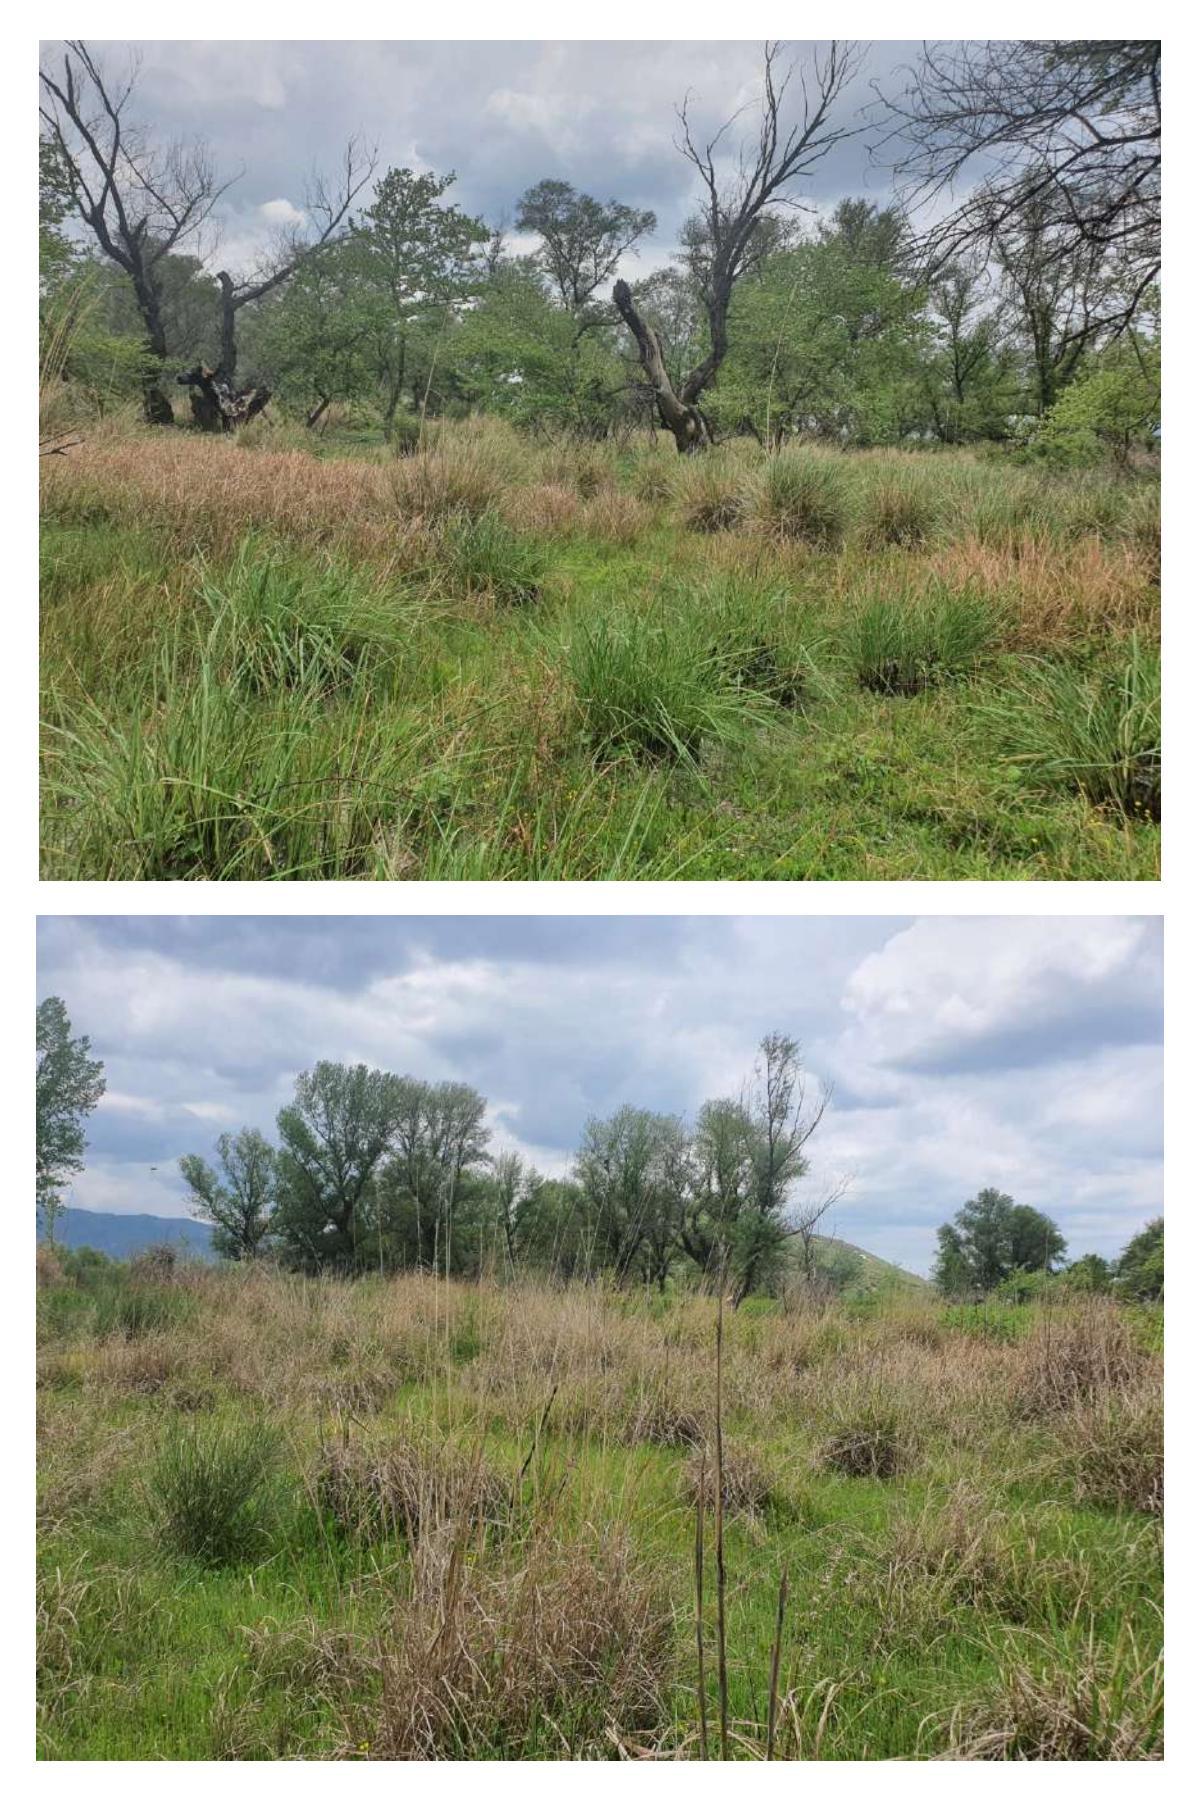
Figure 36. Series of photos to get an impression of the current stand situation

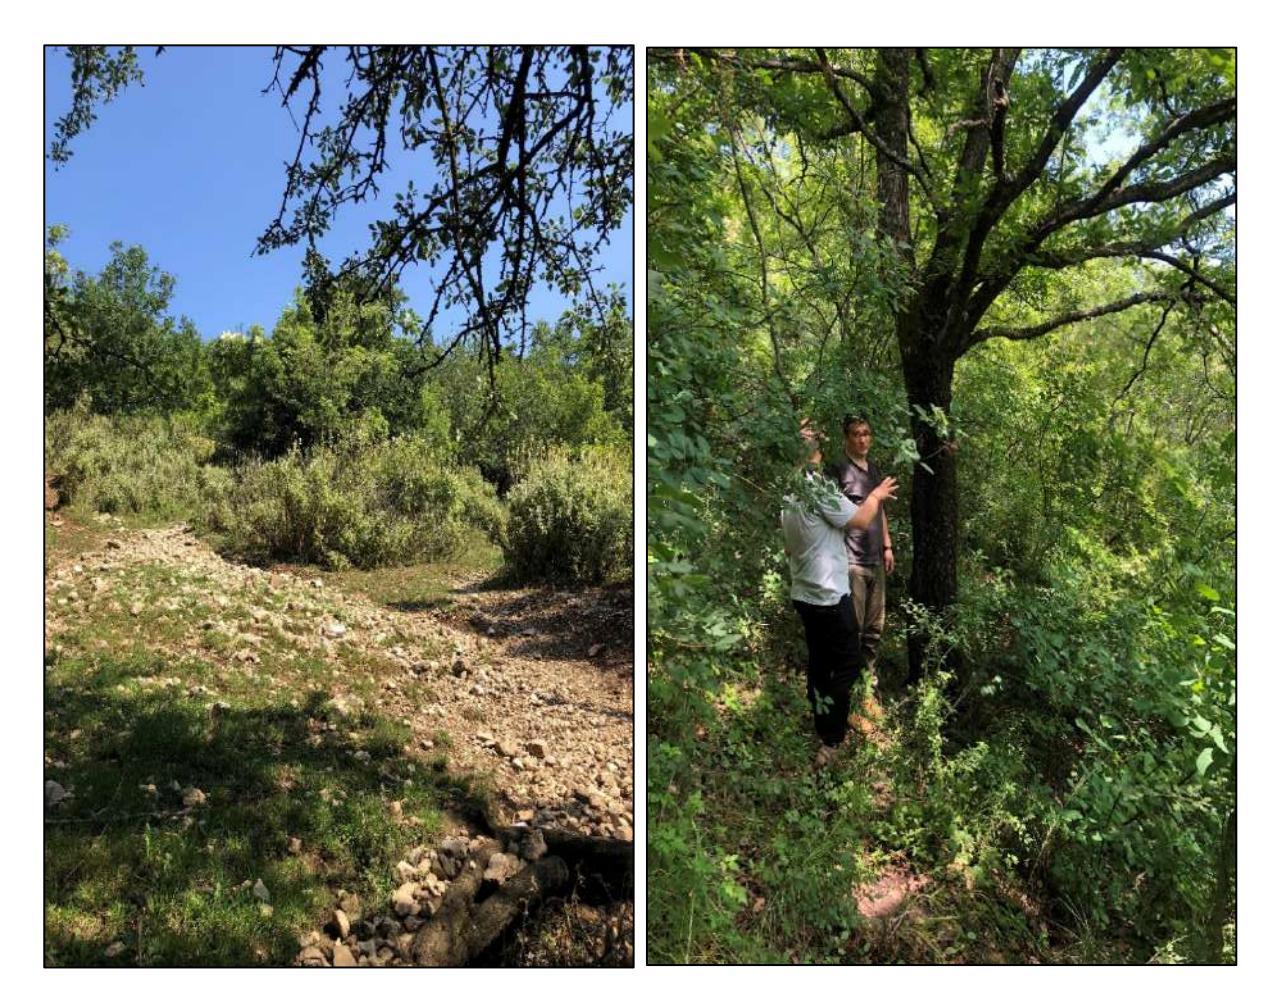
Figure 39. Typical oak stands with forest management and grazing impact but a high potential towards the site specific Potential Natural Vegetation. These sites have experienced forest management impacts and grazing but still maintain some oak trees.

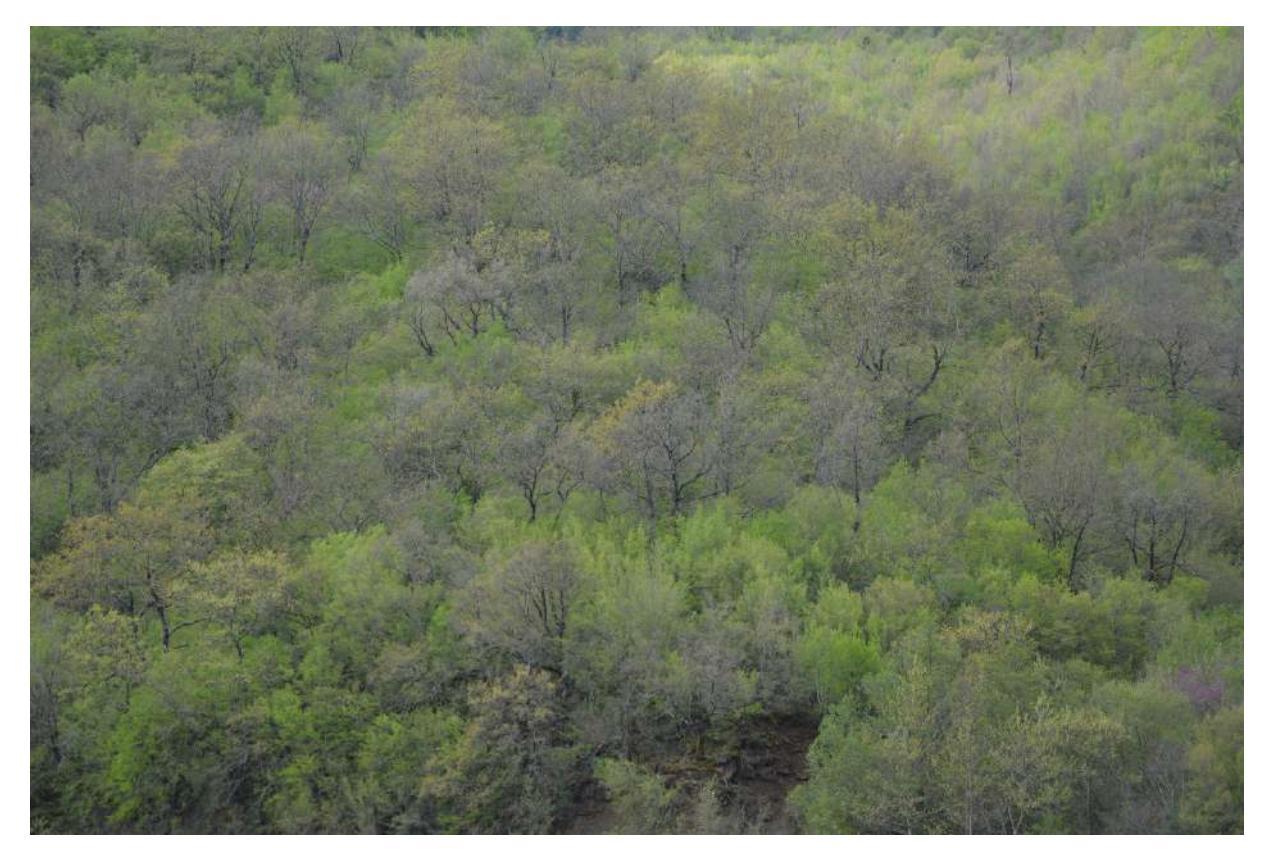
Figure 40. typical Oak forest stands managed in coppice with standard forest management system near the Greek boarder. The forests may be considered as one of the closest forests to the Potential Natural Vegetation in the area and haver relatively little (compared to the other sites) grazing impact. With proper management they can be directed towards the PNV.

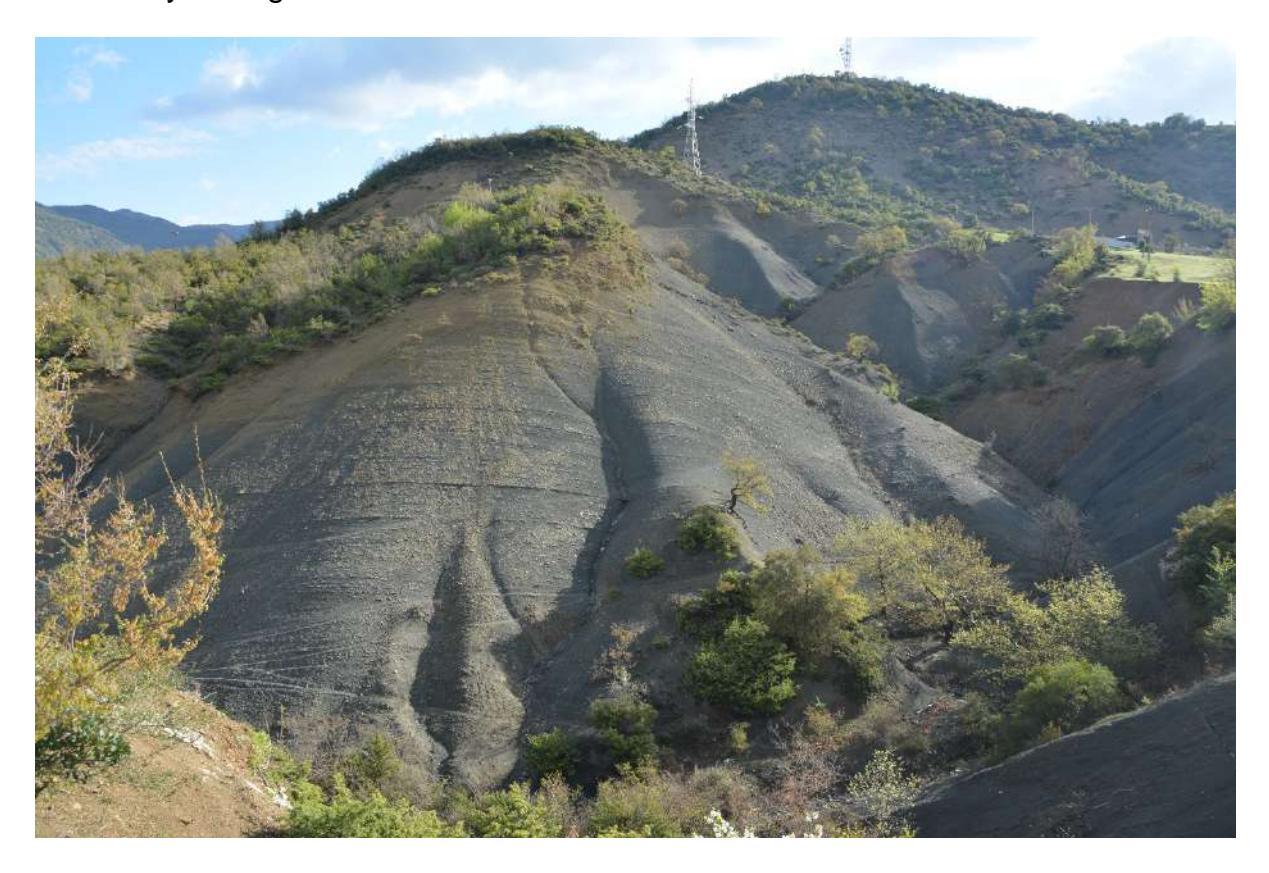
The former oak stands have been cut for fuelwood and the landscape has been shaped by livestock, mainly sheep and goats. The oak stands did not regenerate and as a result, severe degradation took place, leading to soil erosion. The grazing impact has led to a secondary bush vegetation and a recovery of the PNV (mainly *Quercus spp.*) is impossible. In some areas, the erosion was so severe that most of the soil and humus layers is gone.

Figure 42. Example of an extremely degraded site induced by grazing

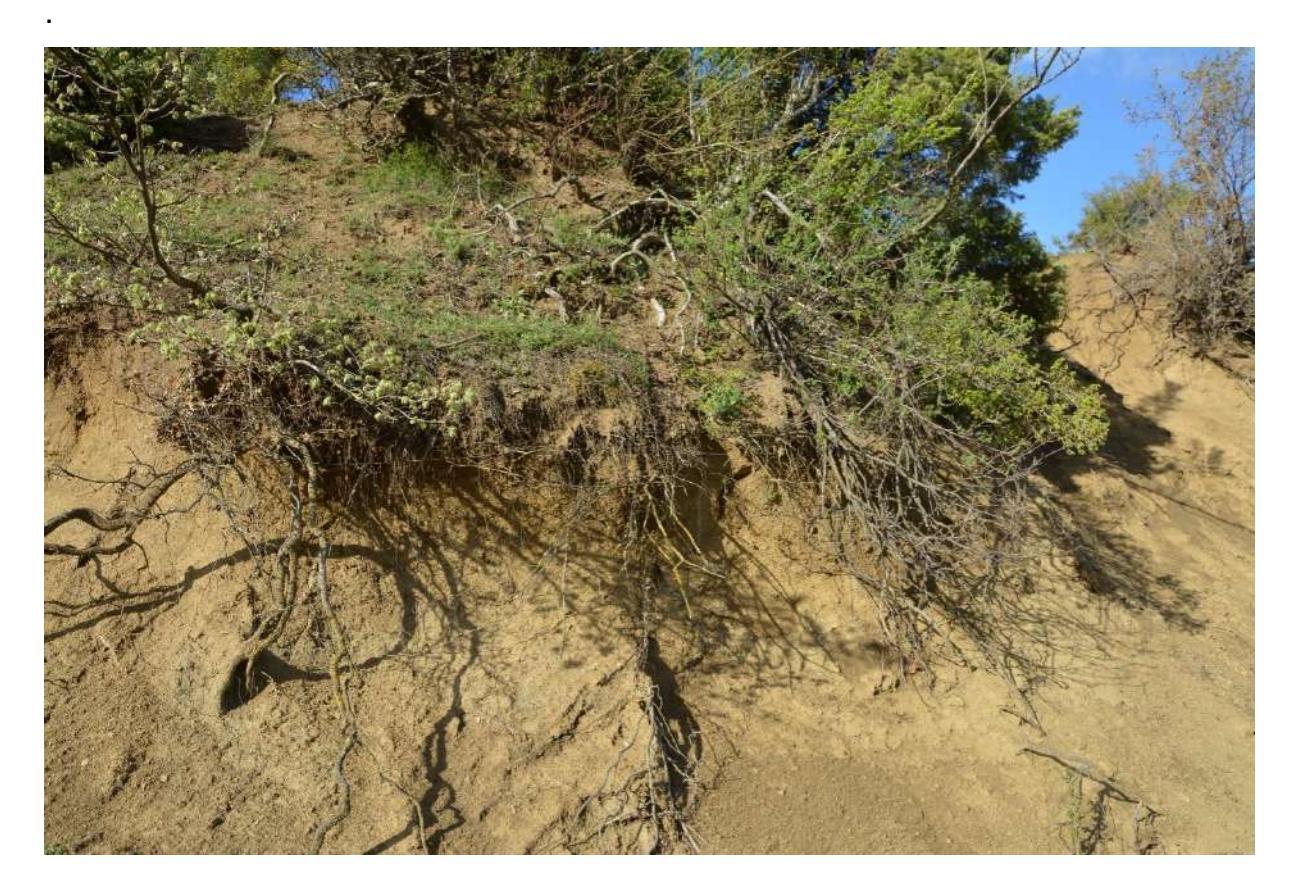
Figure 43. Results of an erosion event at the site

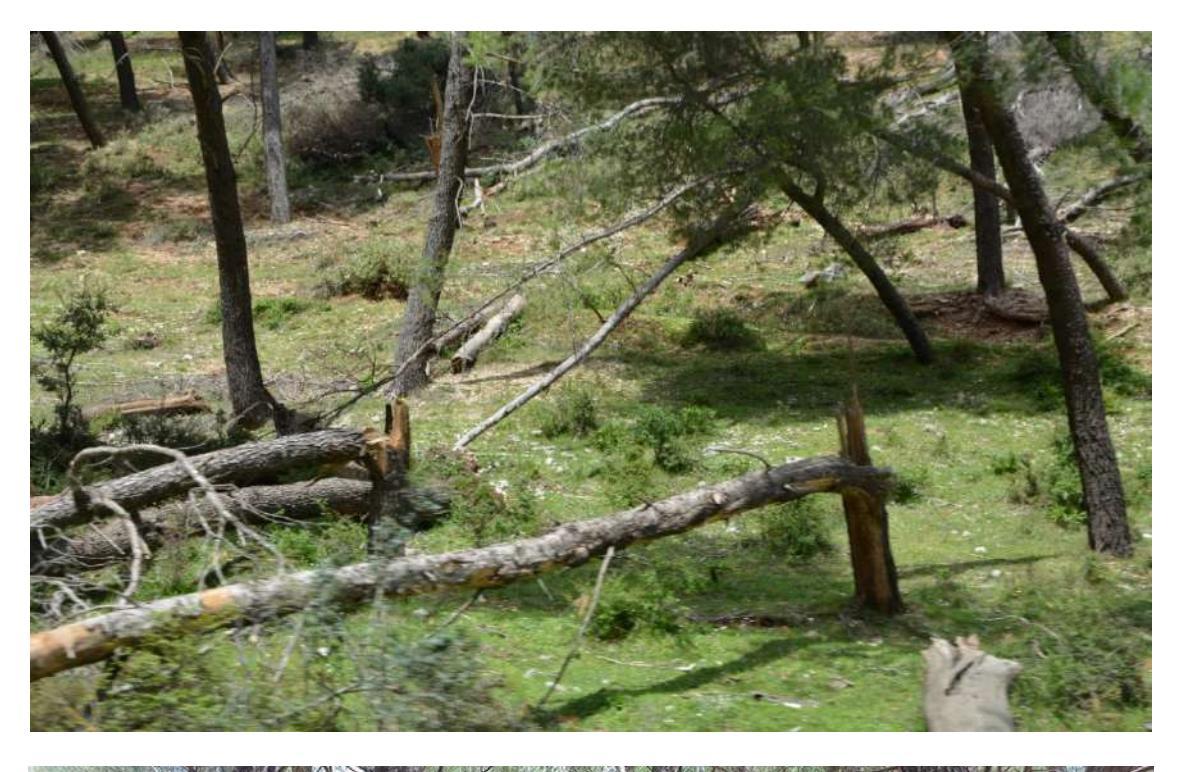
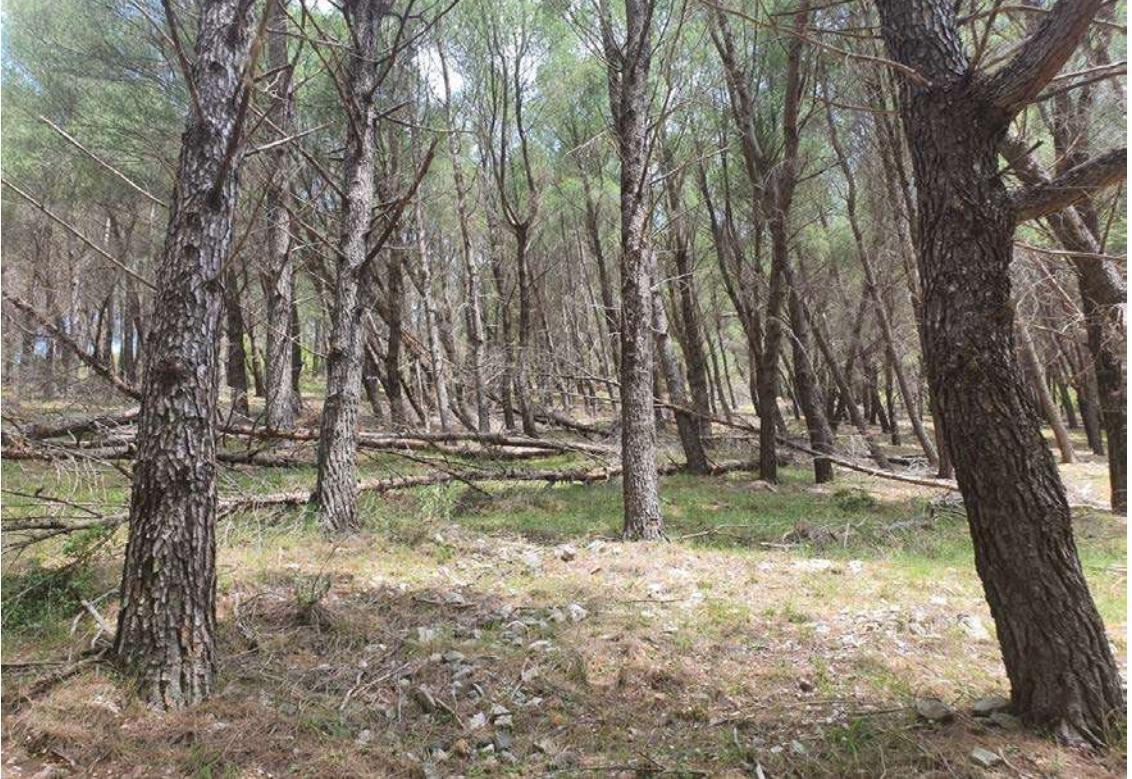
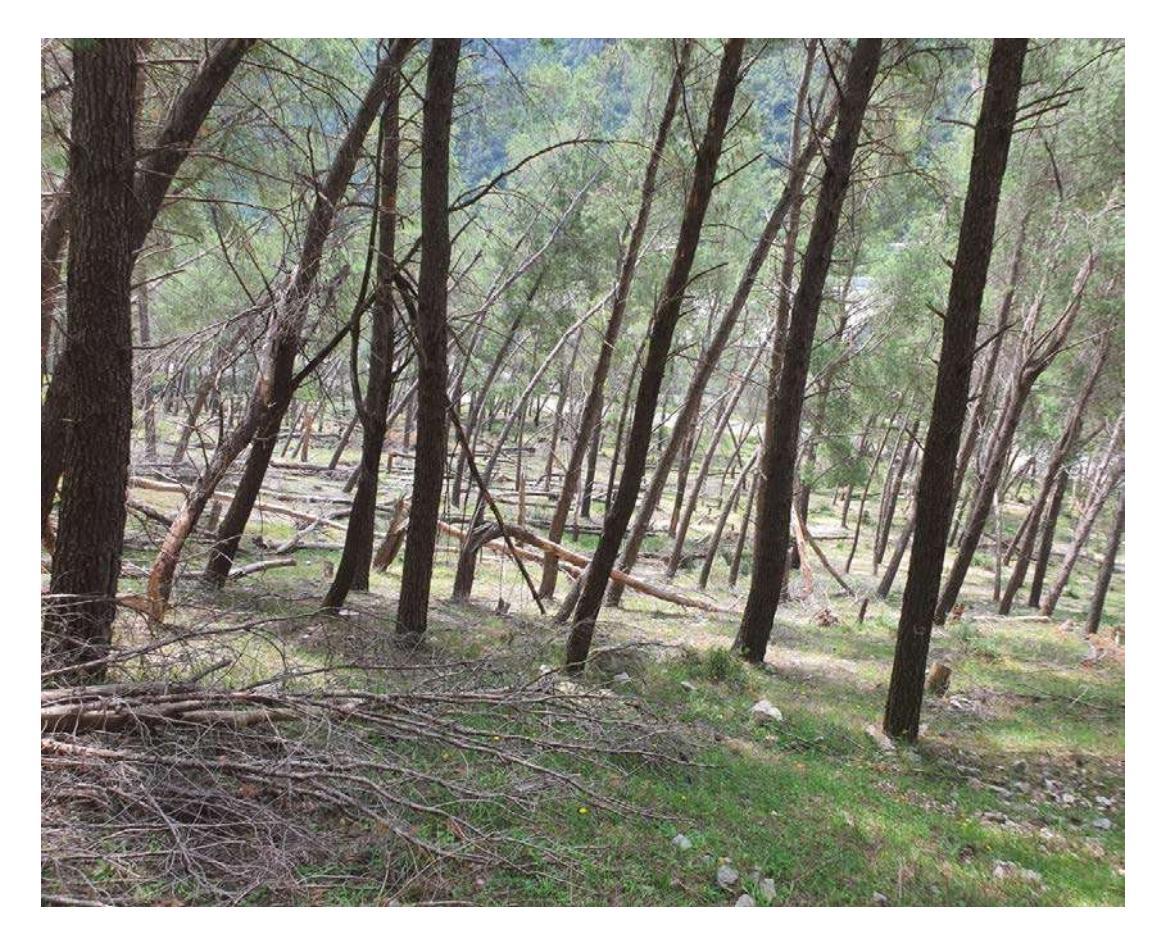
Figure 49. Several *P.halepensis* stands near Kelcyre. It is a typical middleaged pine forest which urgently needs some thinning to enhance the stand stability.

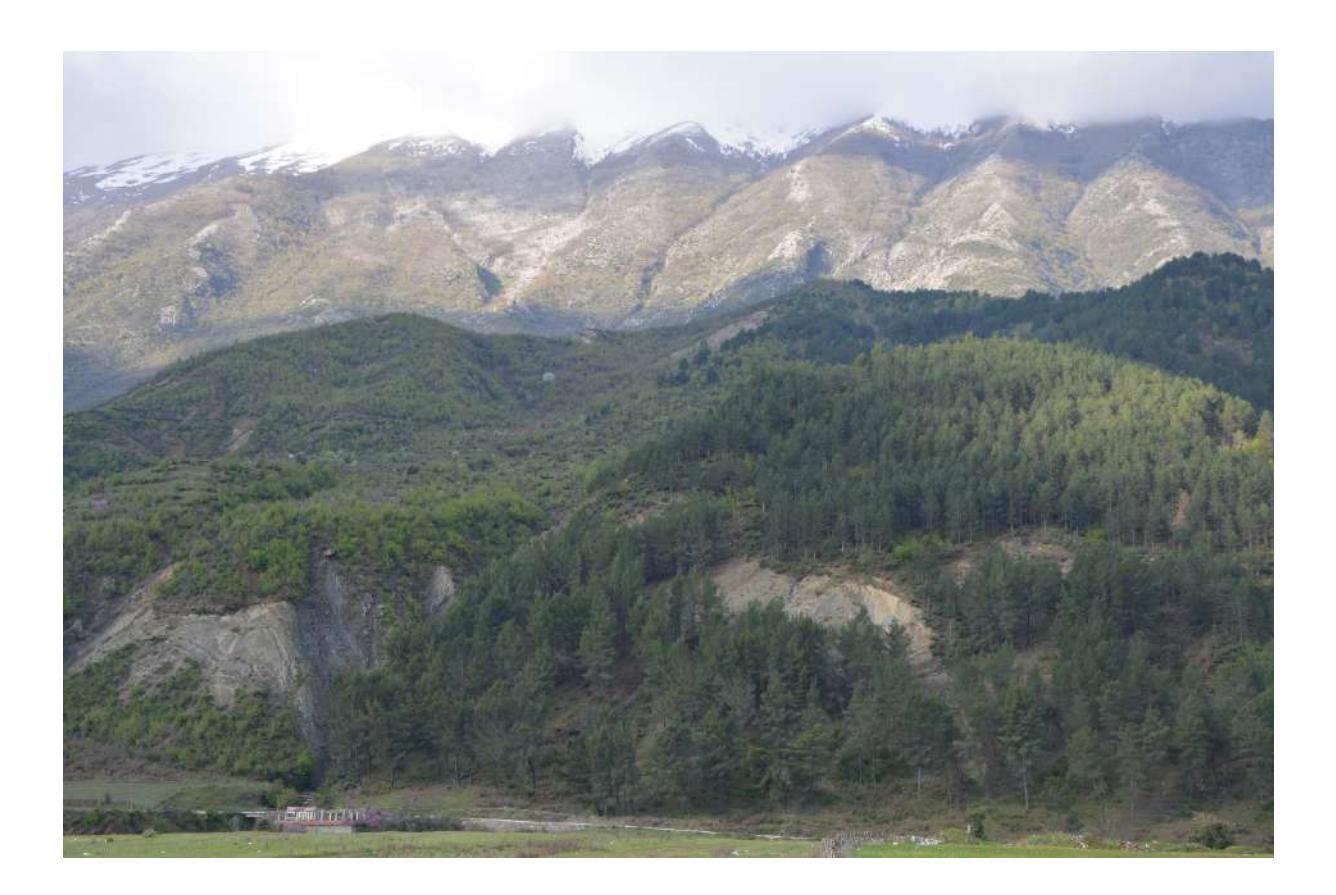
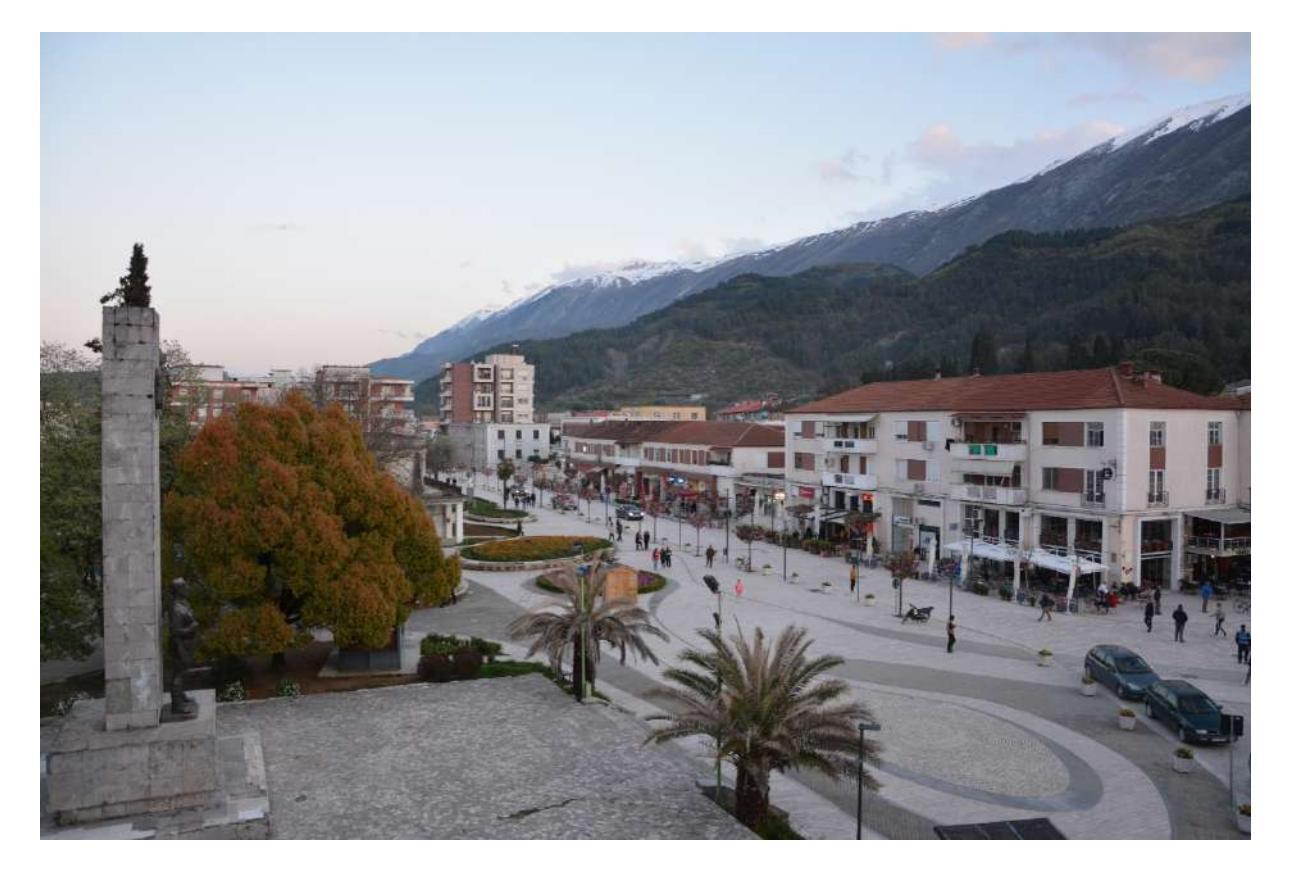
Figure 50. Old pine stands near Permet planted after the second world war. The forest fulfill a protection function for the soil as well as the infrastructure and provide fuel wood and timber for the local population.

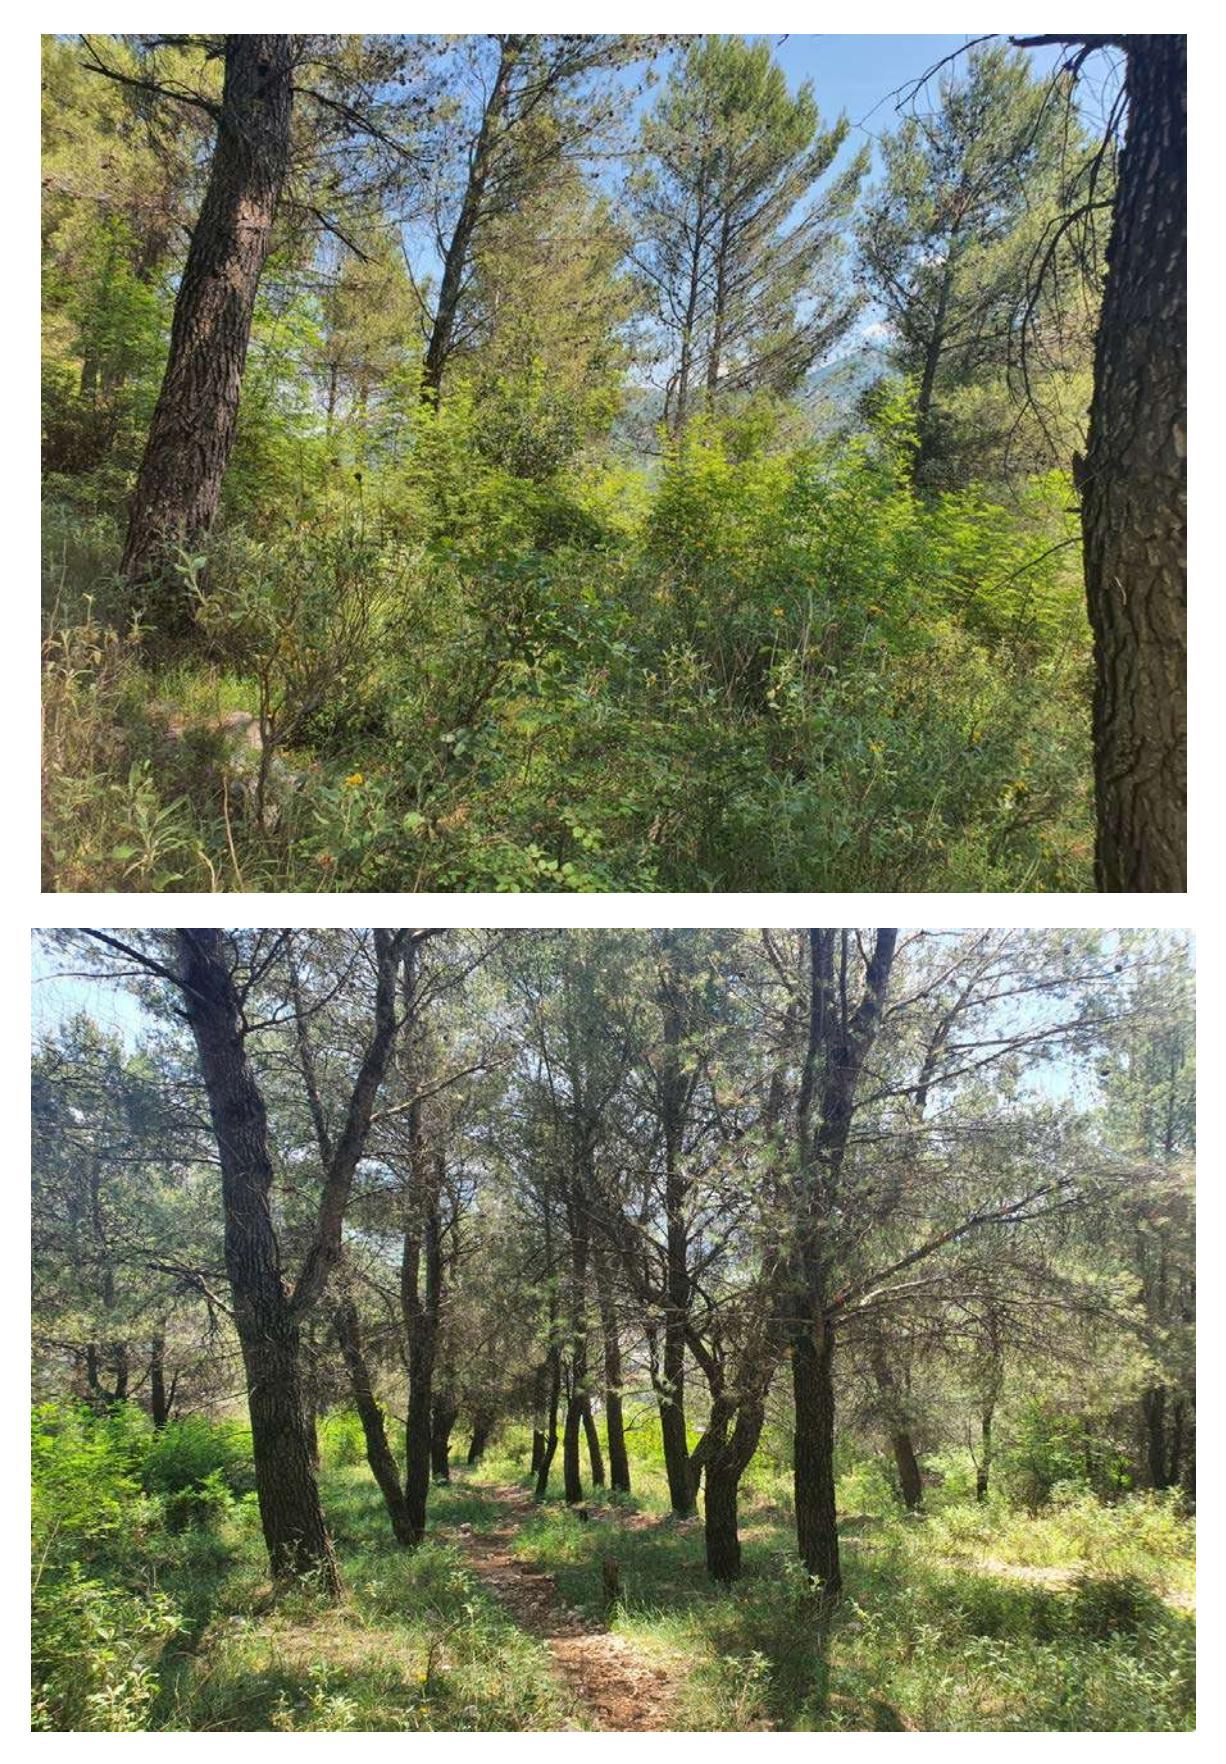
Figure 51. Within stand situation of such old pine stands. Some regeneration of pine but also other species is evident. Forest management for further initiating regeneration is needed.
Current Management and future Development
